Nk'pux Lake  
Fish Potential Assessment  
2023 to 2025

Arsenault Environmental Consulting Ltd. (Arsenault) is pleased to provide the following summary report for a fisheries and NK'pux Lake health assessment to Kanaka Bar Indian Band (the Client). The services specifically relate to a lake condition assessment to determine the potential for the headwater lake (the Site) to support a food-fishery for members of the Kanaka Bar Indian Band. This program is intended to help community members to create a management plan for the creation of a sustainable fishery at the lake.

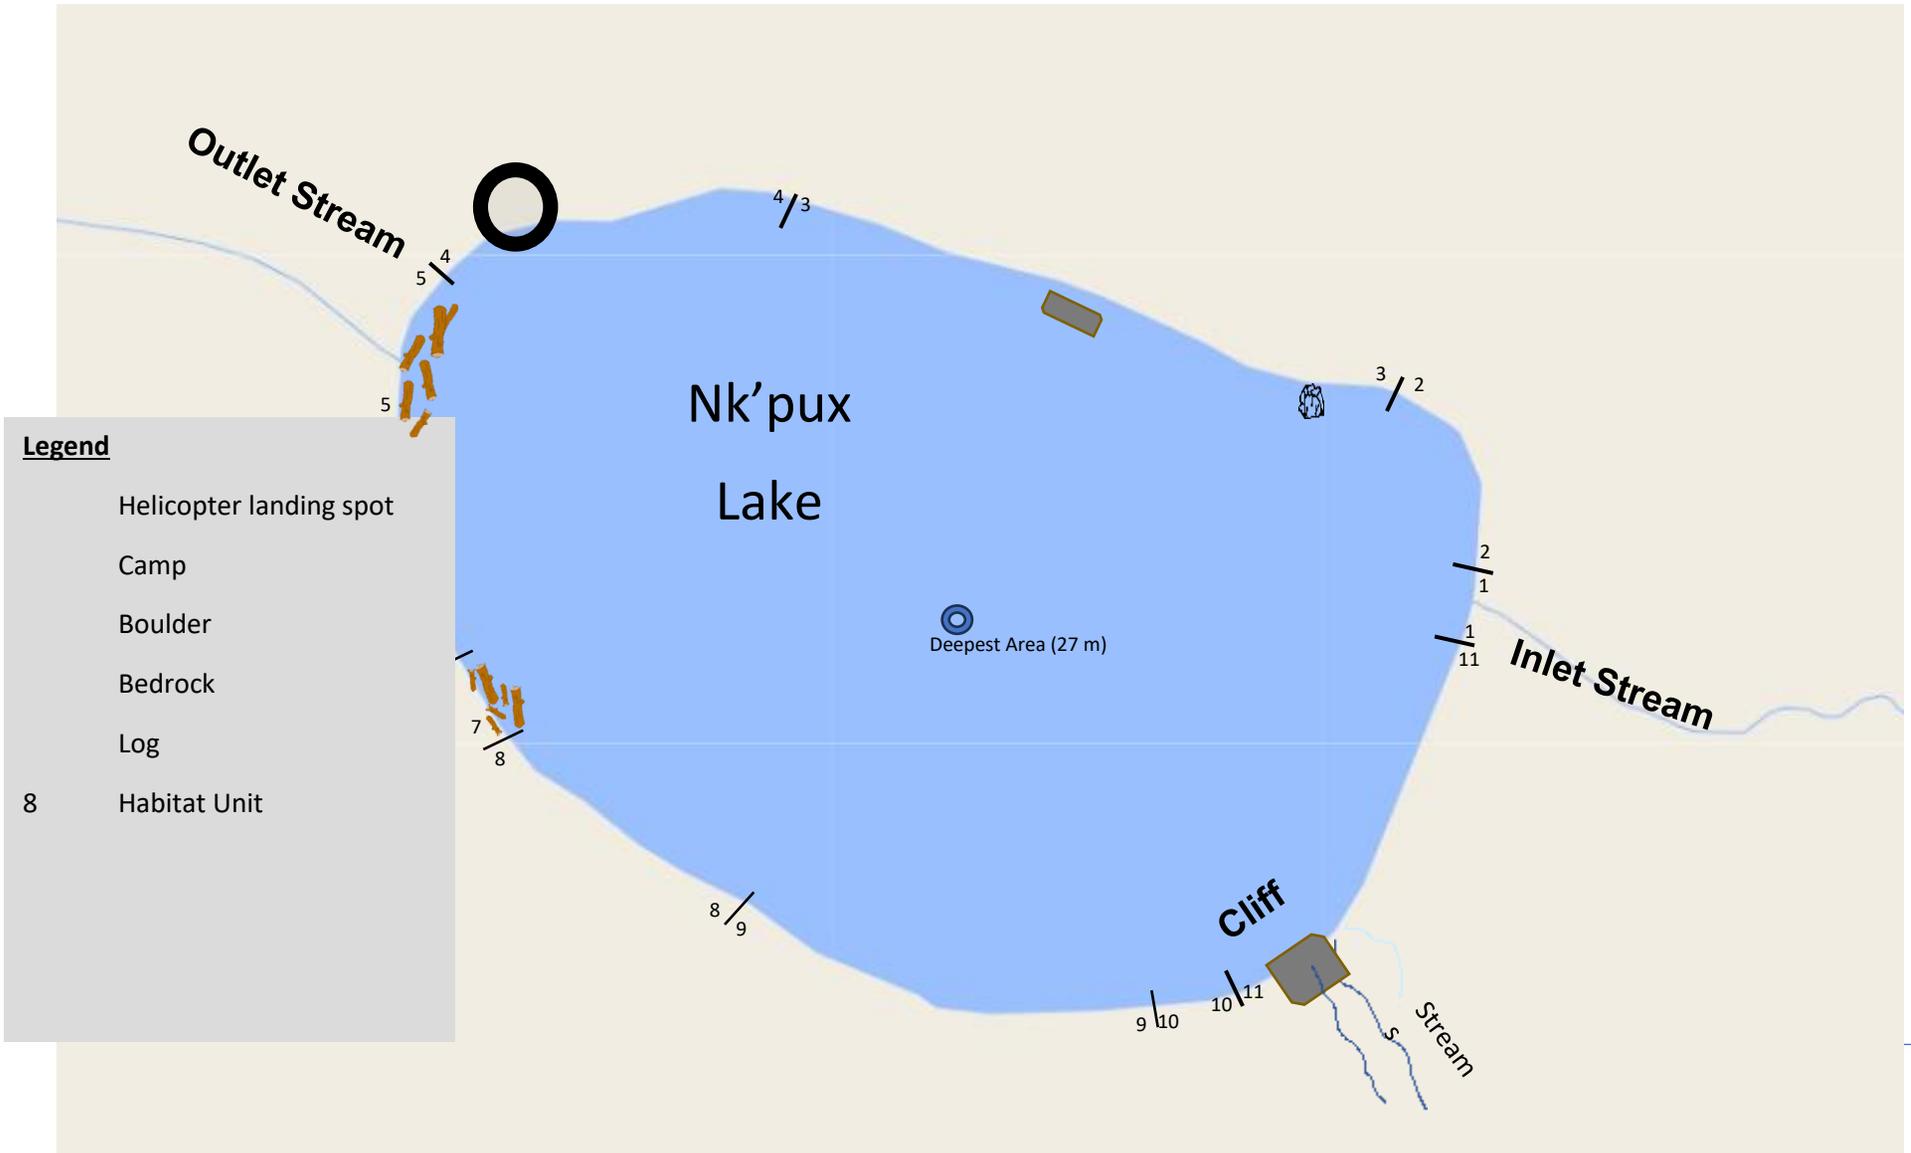
Figure 1. Nk'pux Lake Habitat Map (description provided below the figure)

Lake Habitat Zone Description – 11 Units

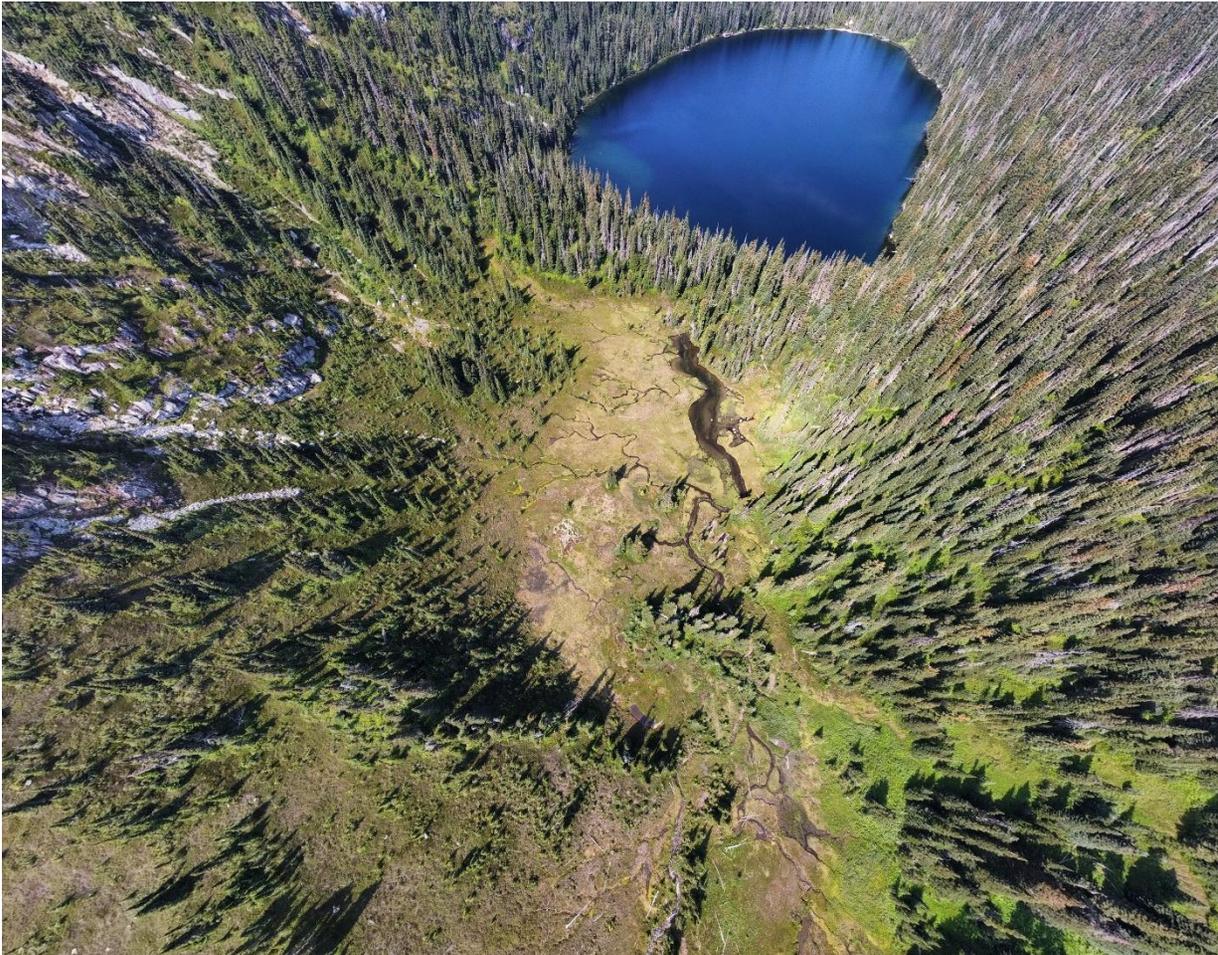
There is a small section of gravel habitat at the inlet stream at the east end of the lake that would provide moderate fish spawning potential. It could be possible to enhance its spawning habitat quality. The stream becomes too steep for fish within 35 m of the lake.

It could be possible to enhance its spawning habitat quality. The stream becomes too steep for fish within 35 m of the lake.

There is a small section of gravel habitat at the inlet stream at the east end of the lake that would provide moderate fish spawning potential. It could be possible to enhance its spawning habitat quality. The stream gradient becomes too steep for fish within 35 m of the lake.

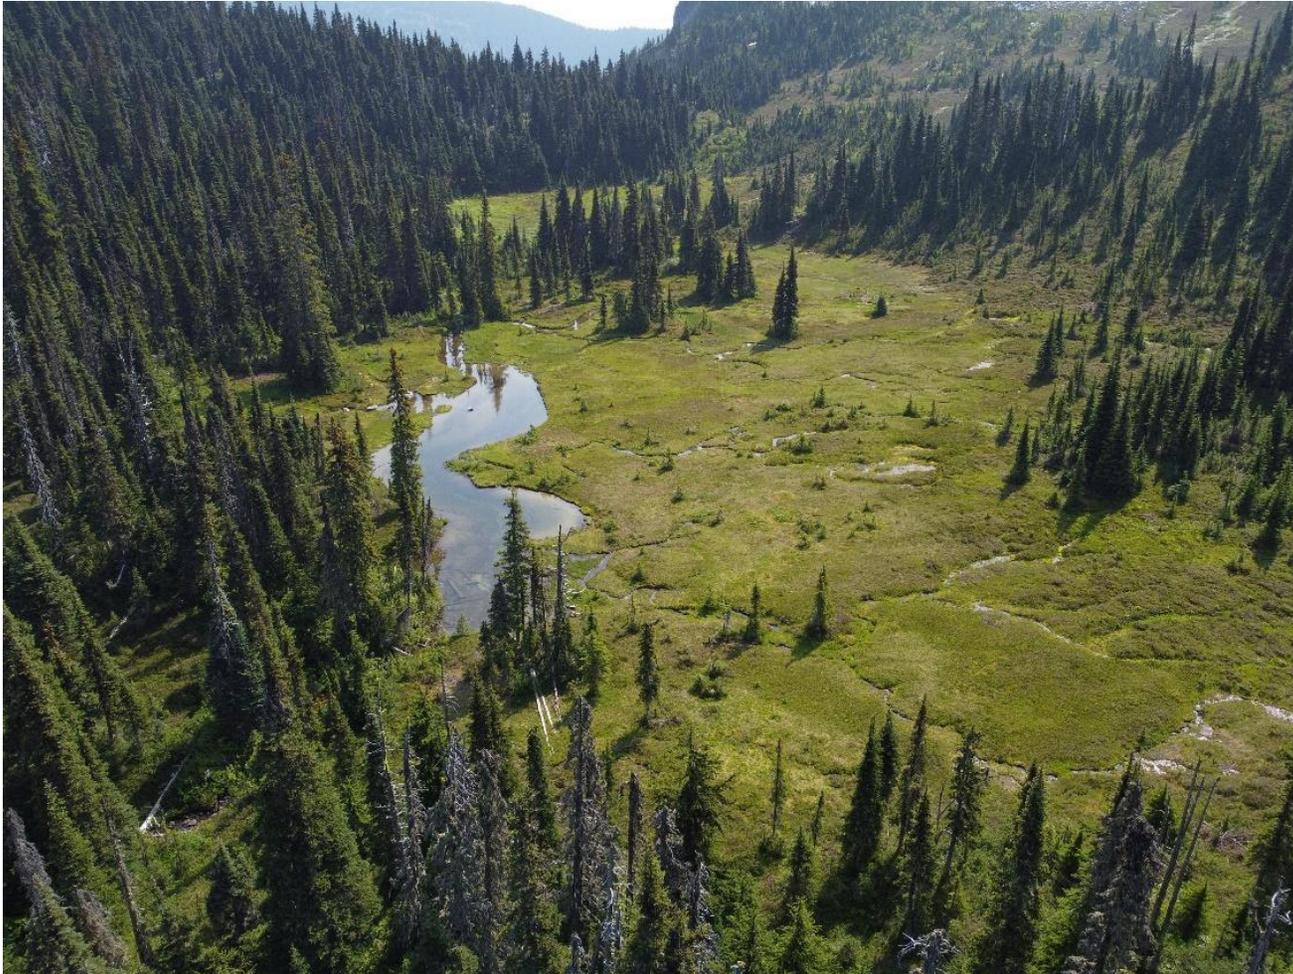
**Photo 2.** This is the inlet of N'k'pux lake, the photo was taken with a drone. There is a flat stream area on a bench about 120 m to the east of the lake. Fish could survive during summers here but there is very little cover or food noticed. The stream could freeze to the bottom during winter.

There is a flat stream area on a bench about 120 m to the east of the lake. Fish could survive here but there is very little cover or food noticed. It is too shallow (<1 m deep) to allow fish to overwinter.

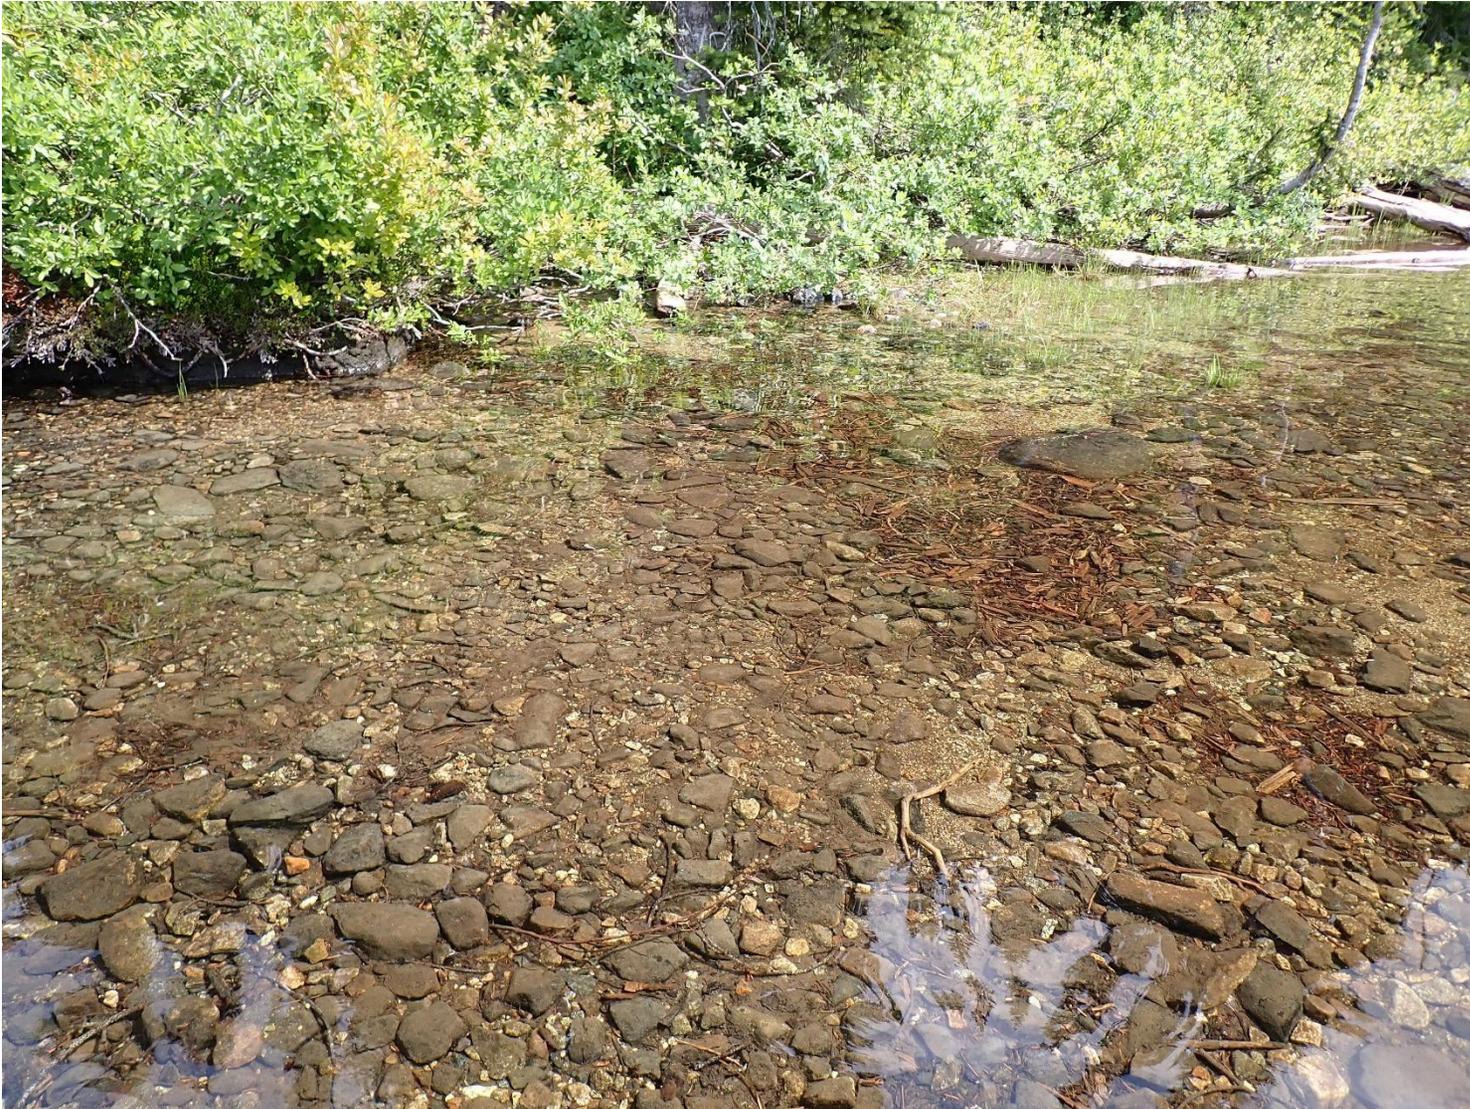
**Photo 3.** This shows the inlet stream on the sub-alpine plateau above the lake. Lots of seepage water from the steep slope to the right.– July 2023. Frogs were seen and heard here.

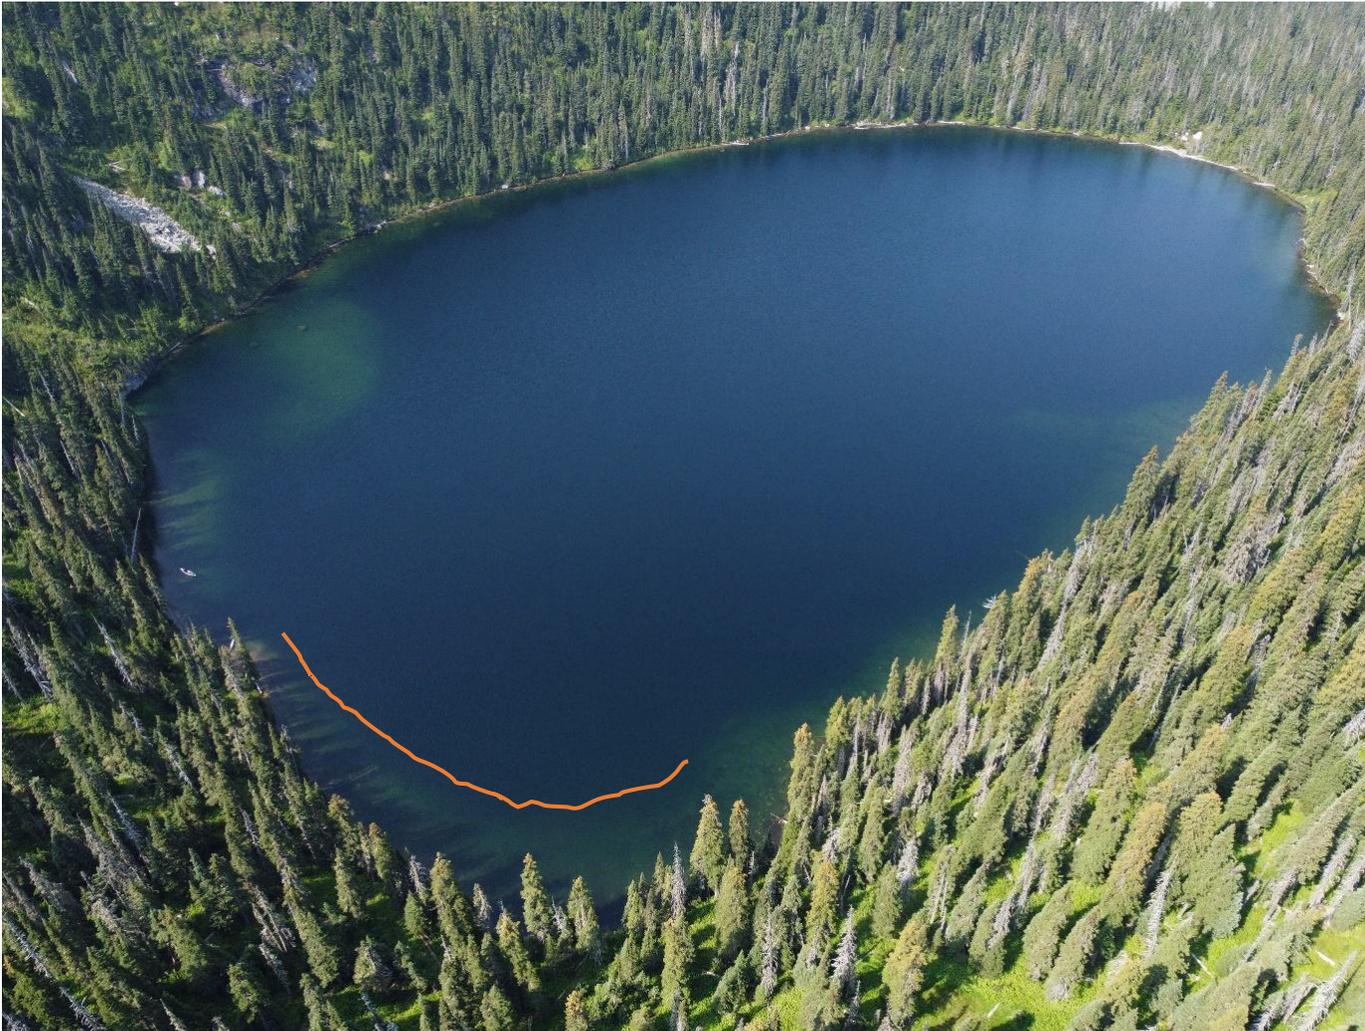
**Photo 4.** Habitat unit 1 is at the mouth of the inlet stream and could be used as spawning habitat by trout or Kokanee.

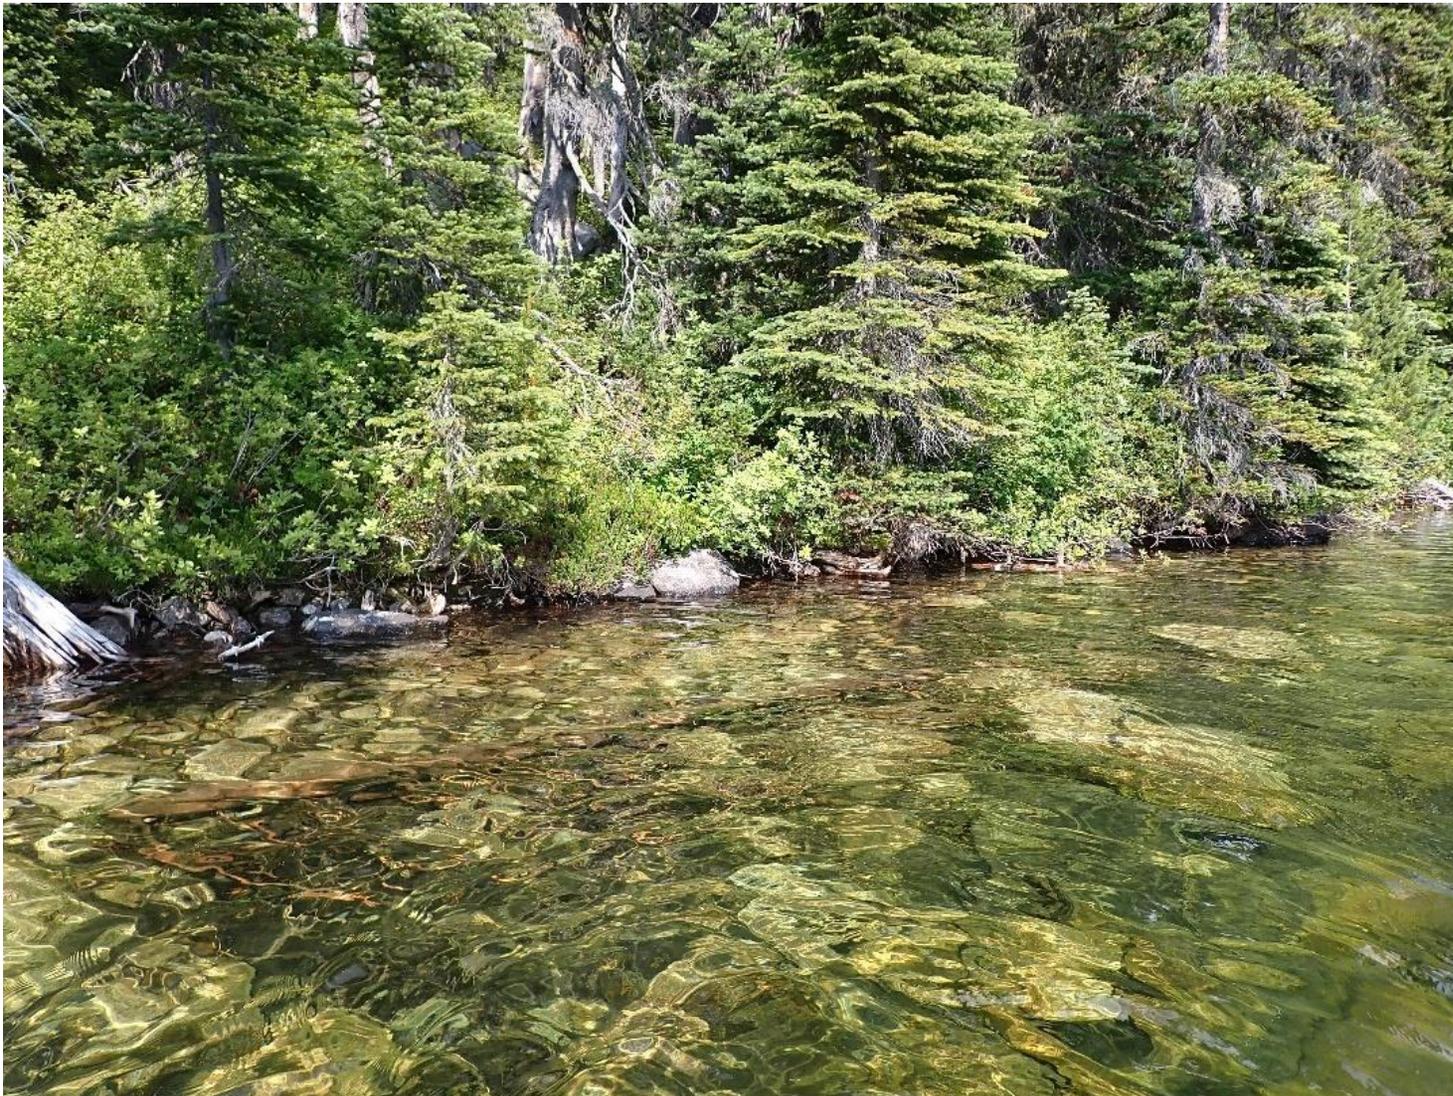
**Photo 6.** Typical habitat in Zone 2 with large flat rocks and a band of gravel next to overhanging banks.

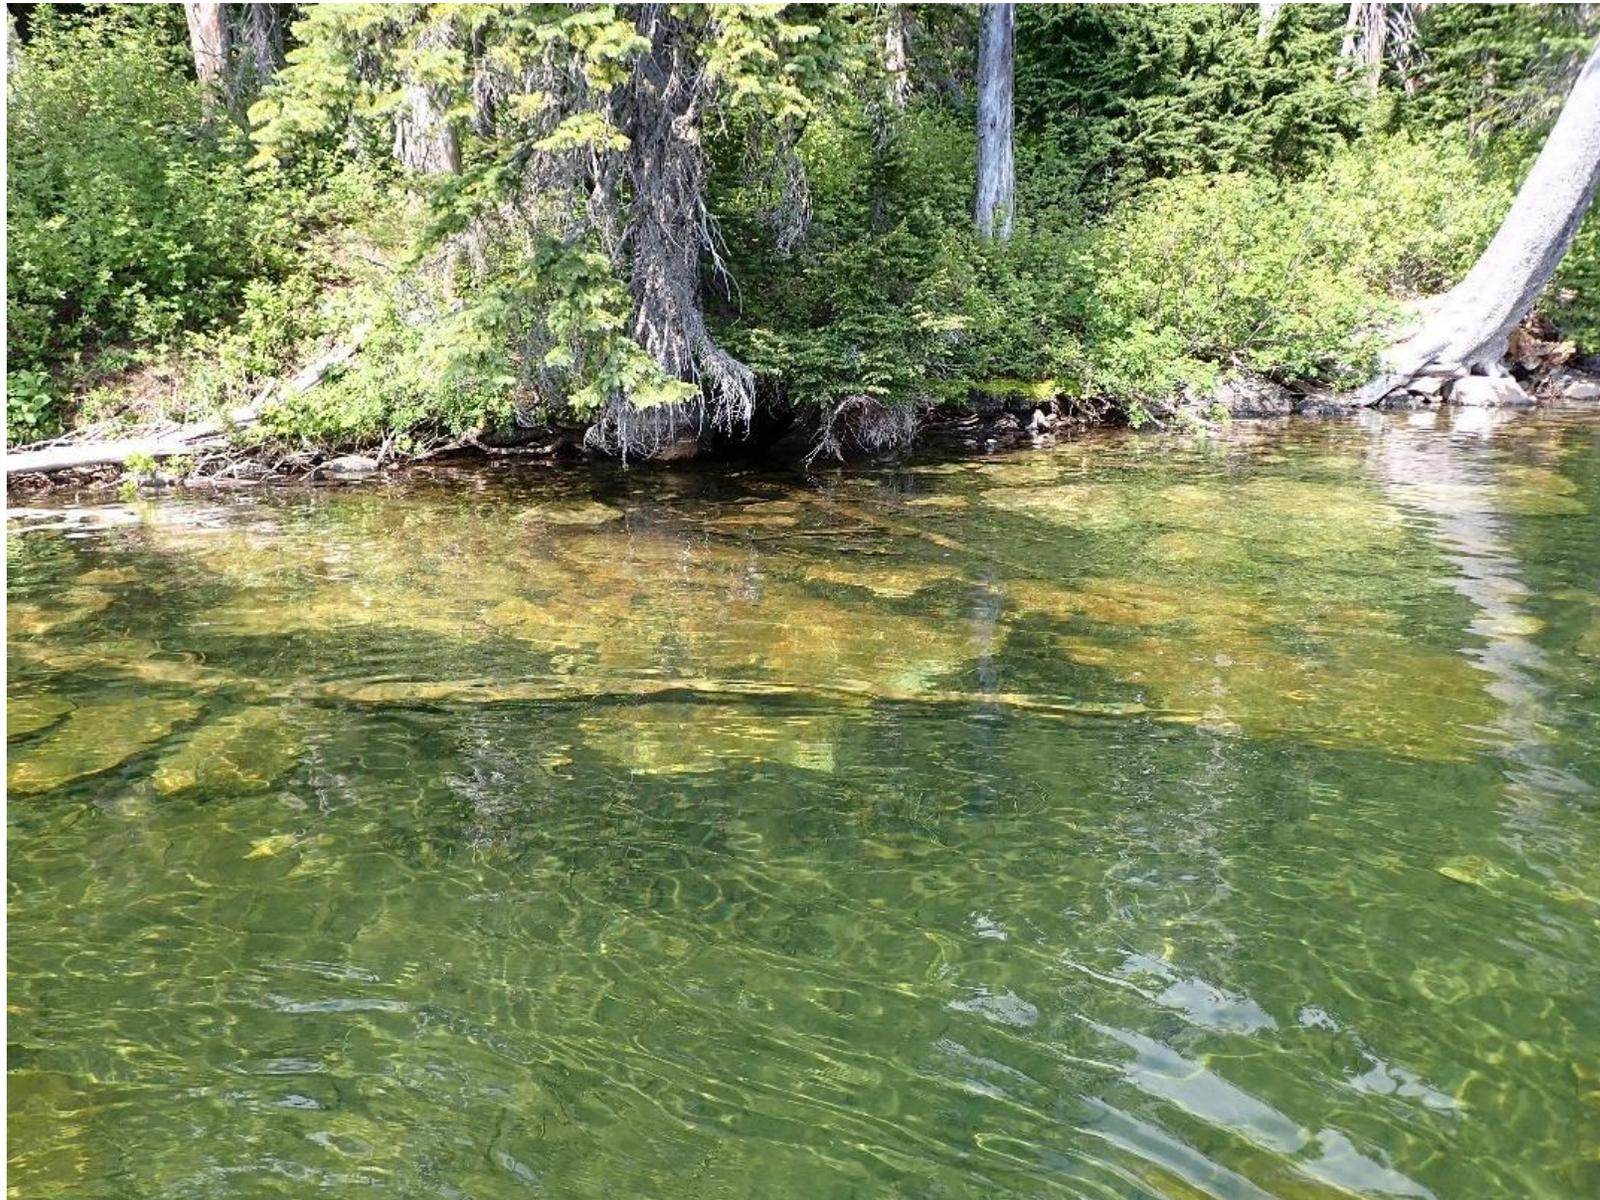
**Photo 7.** Typical representation of Habitat Unit 3. Cobble along shore would not provide spawning habitat for salmonids.

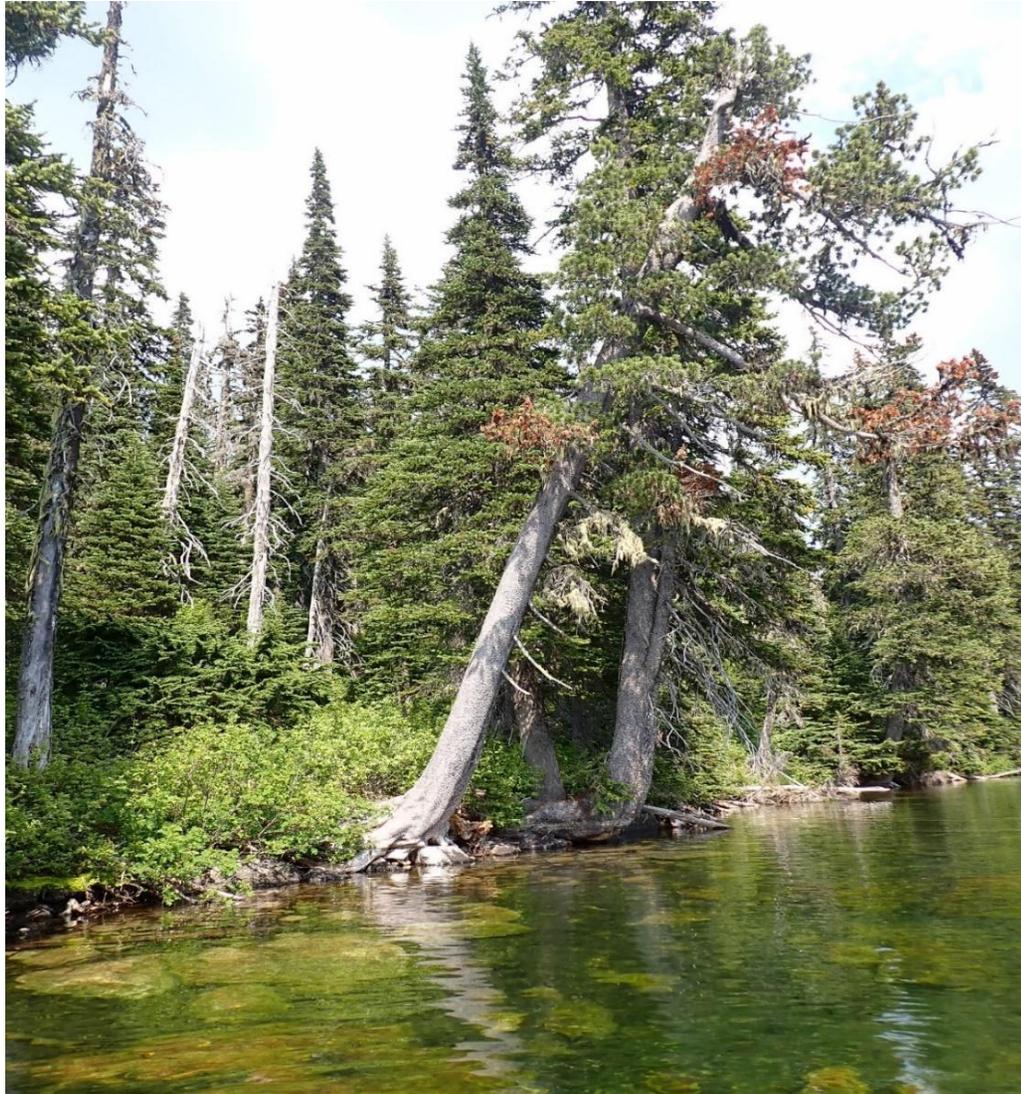
**Photo 8.** The flat bedrock in habitat Zone 3 can be seen in this photo.

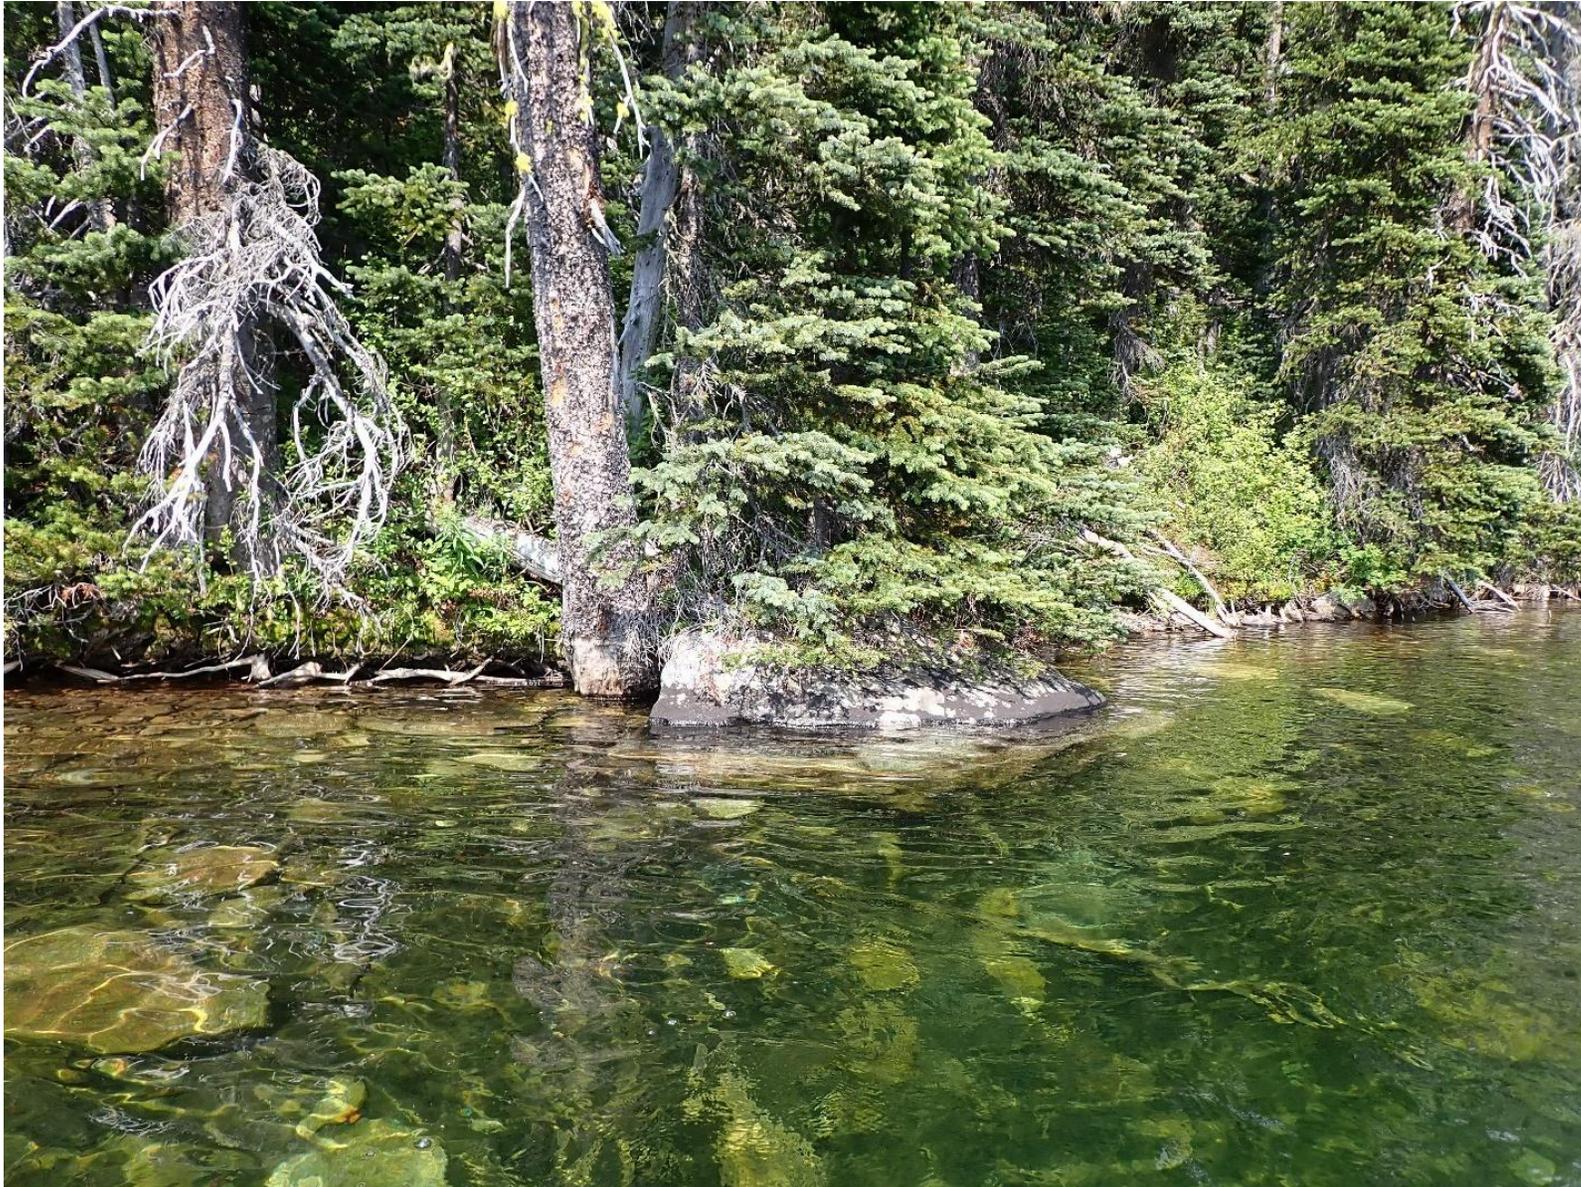
**Photo 10.** The First boulder counterclockwise in Zone 3. These big rocks in the water are not suitable for trout spawning.

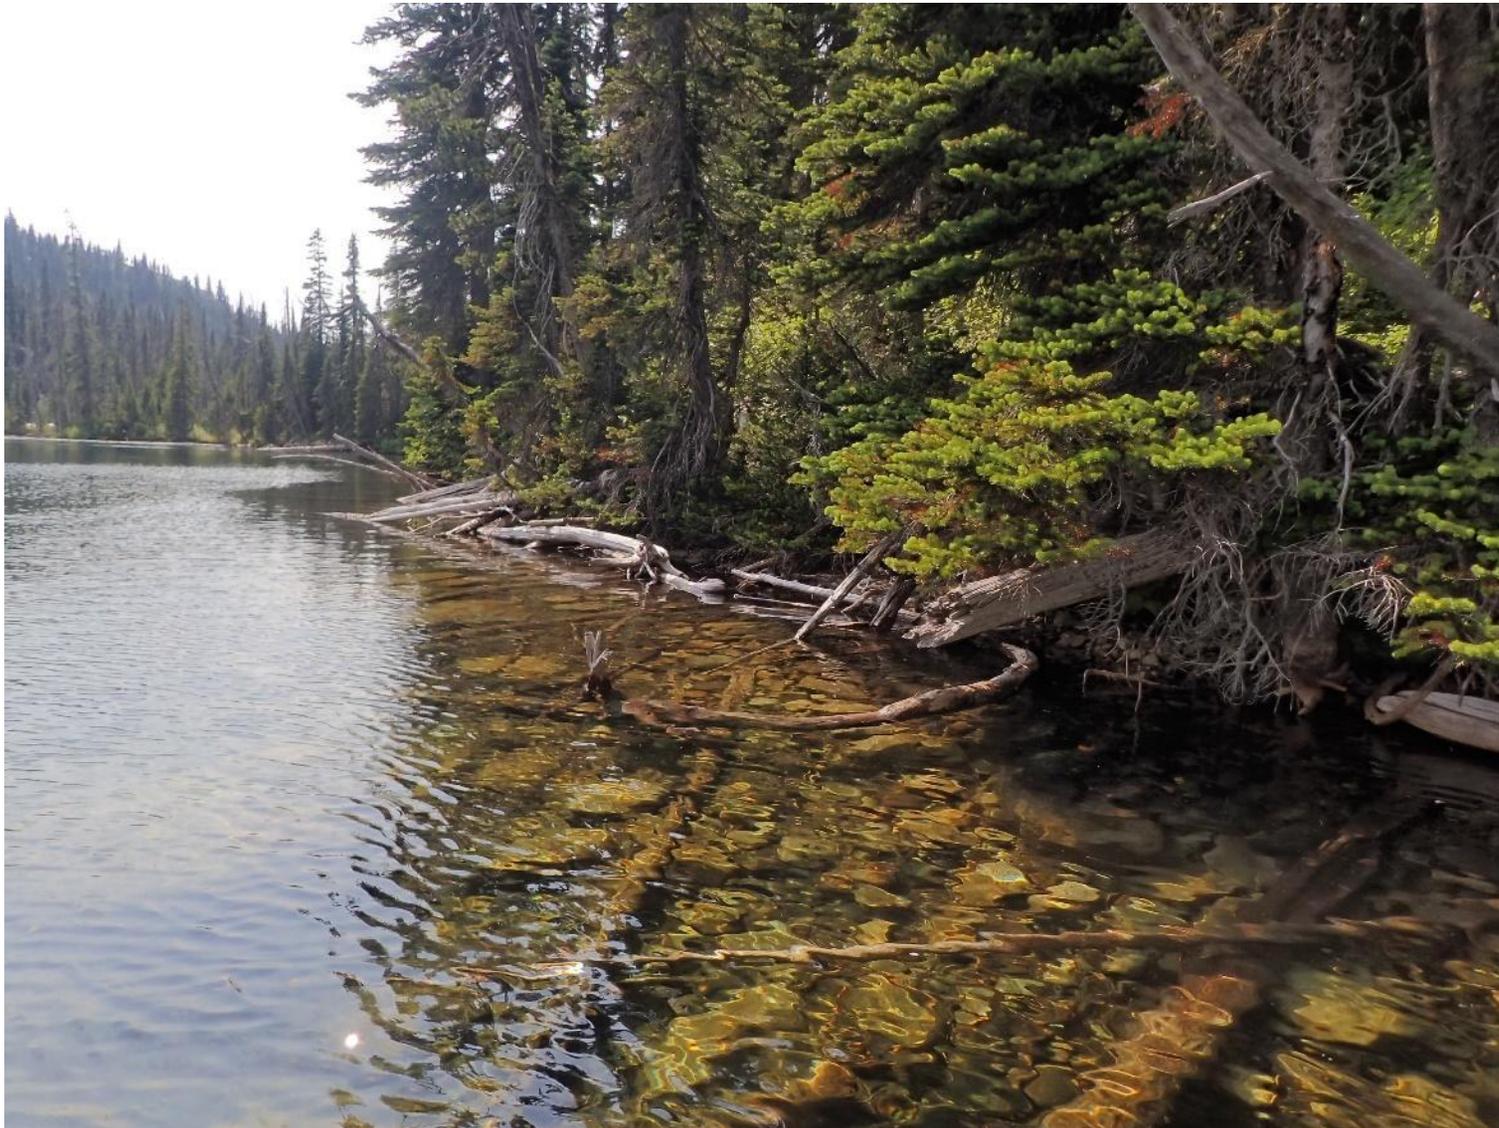
**Photo 12.** Continuing counterclockwise around the lake, this is looking west from the start of Zone 4. A low potential for trout spawning.

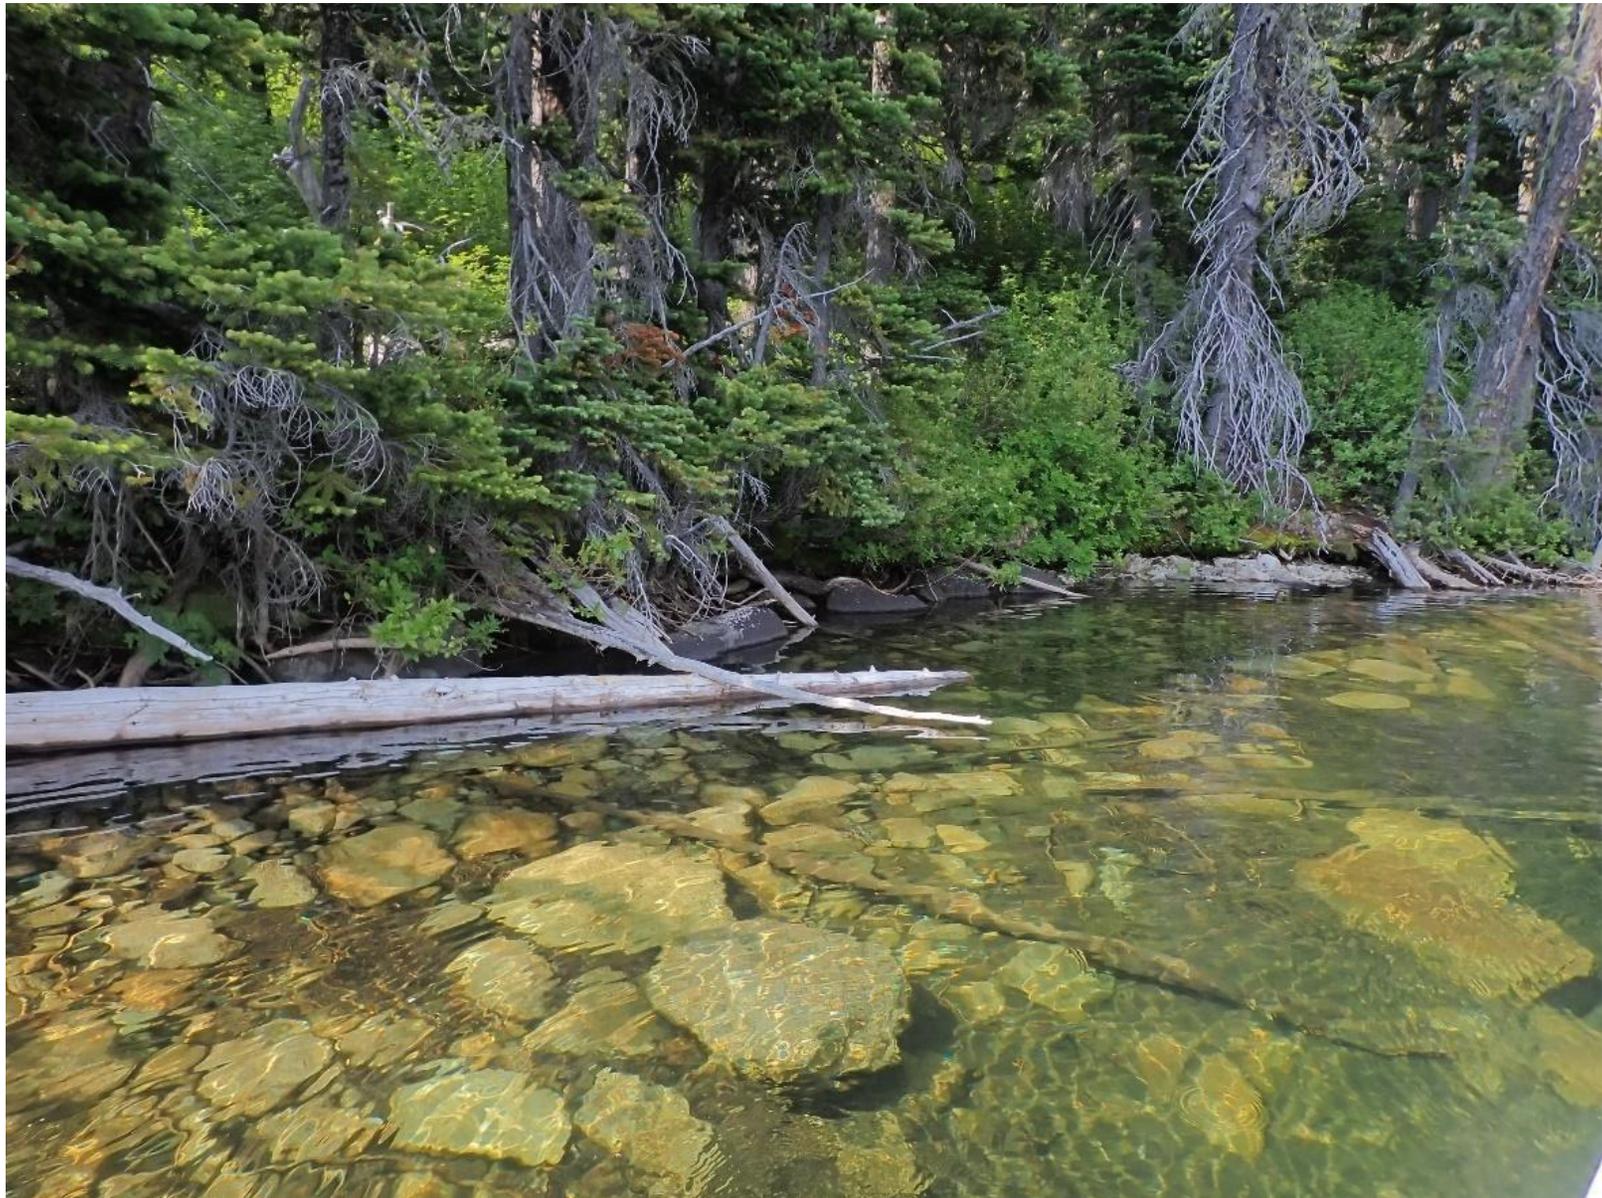
**Photo 14.** Representative habitat of Zone 4 showing the rocks in this zone very clearly. Not a high potential for trout spawning.

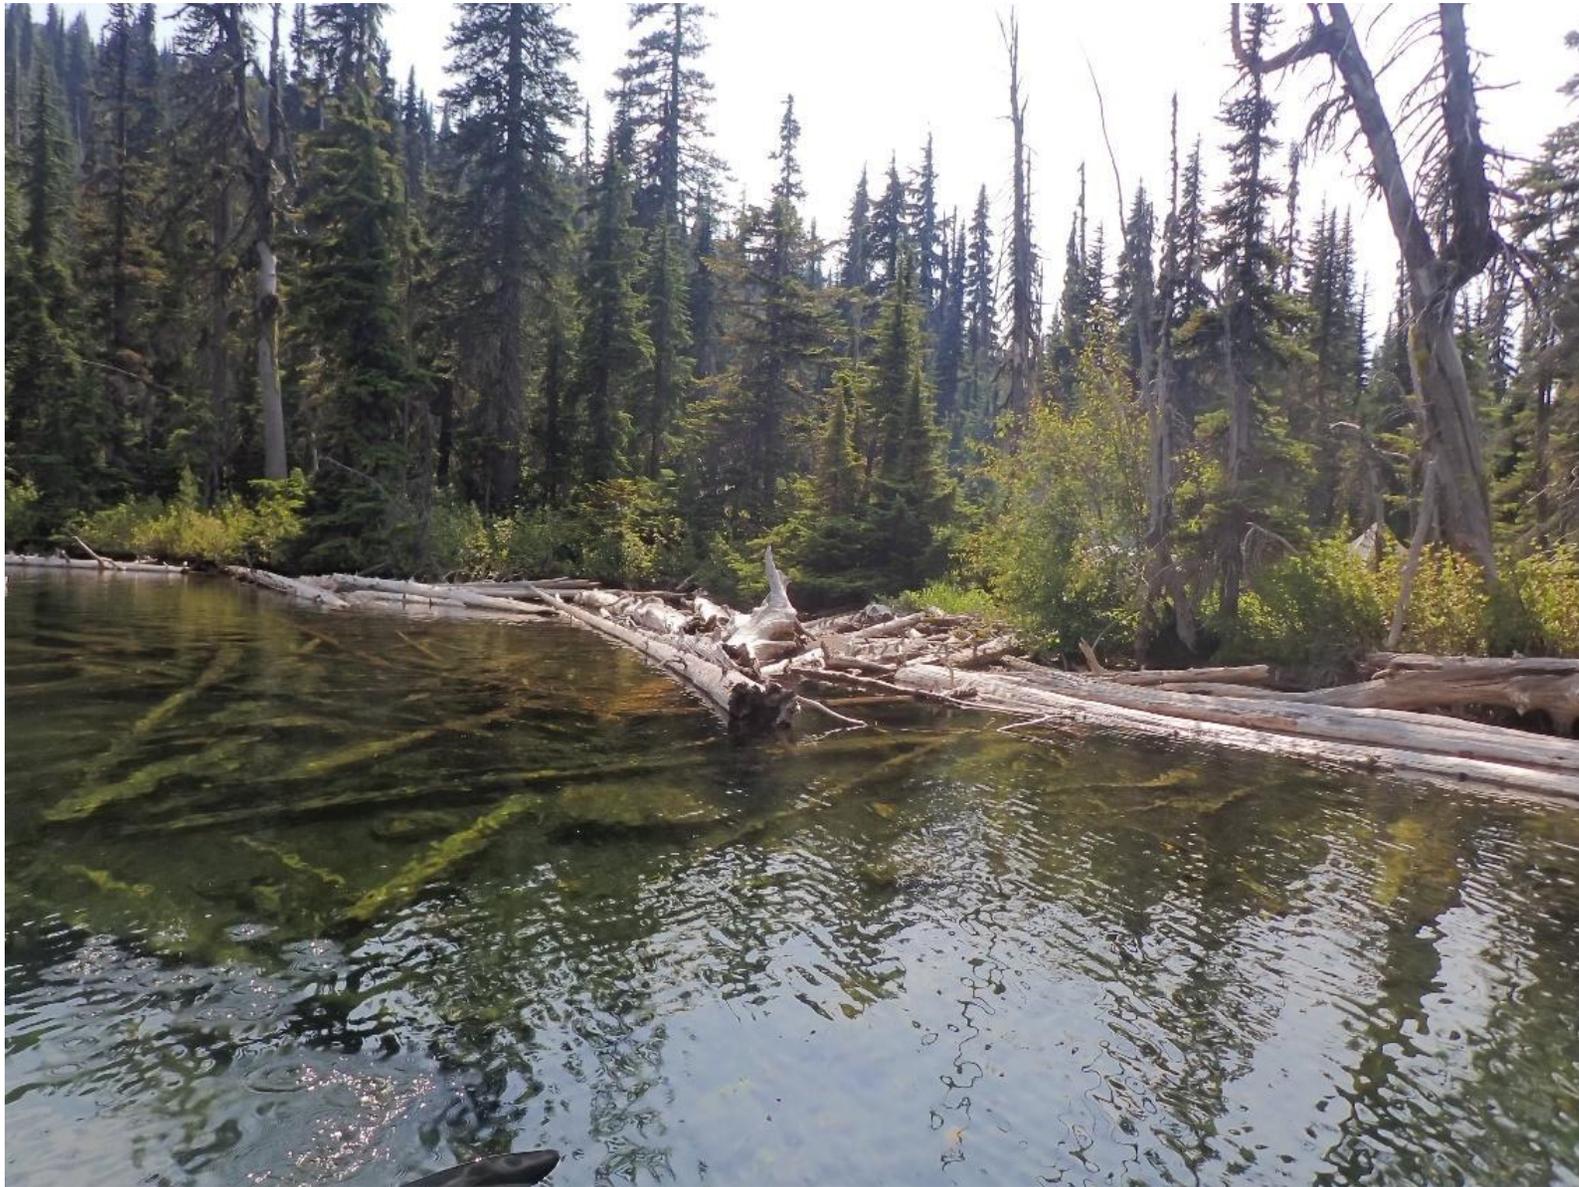
**Photo 15.** This is at the west end of Zone 5. The creek outlet is where the logs stick out the farthest from shore.

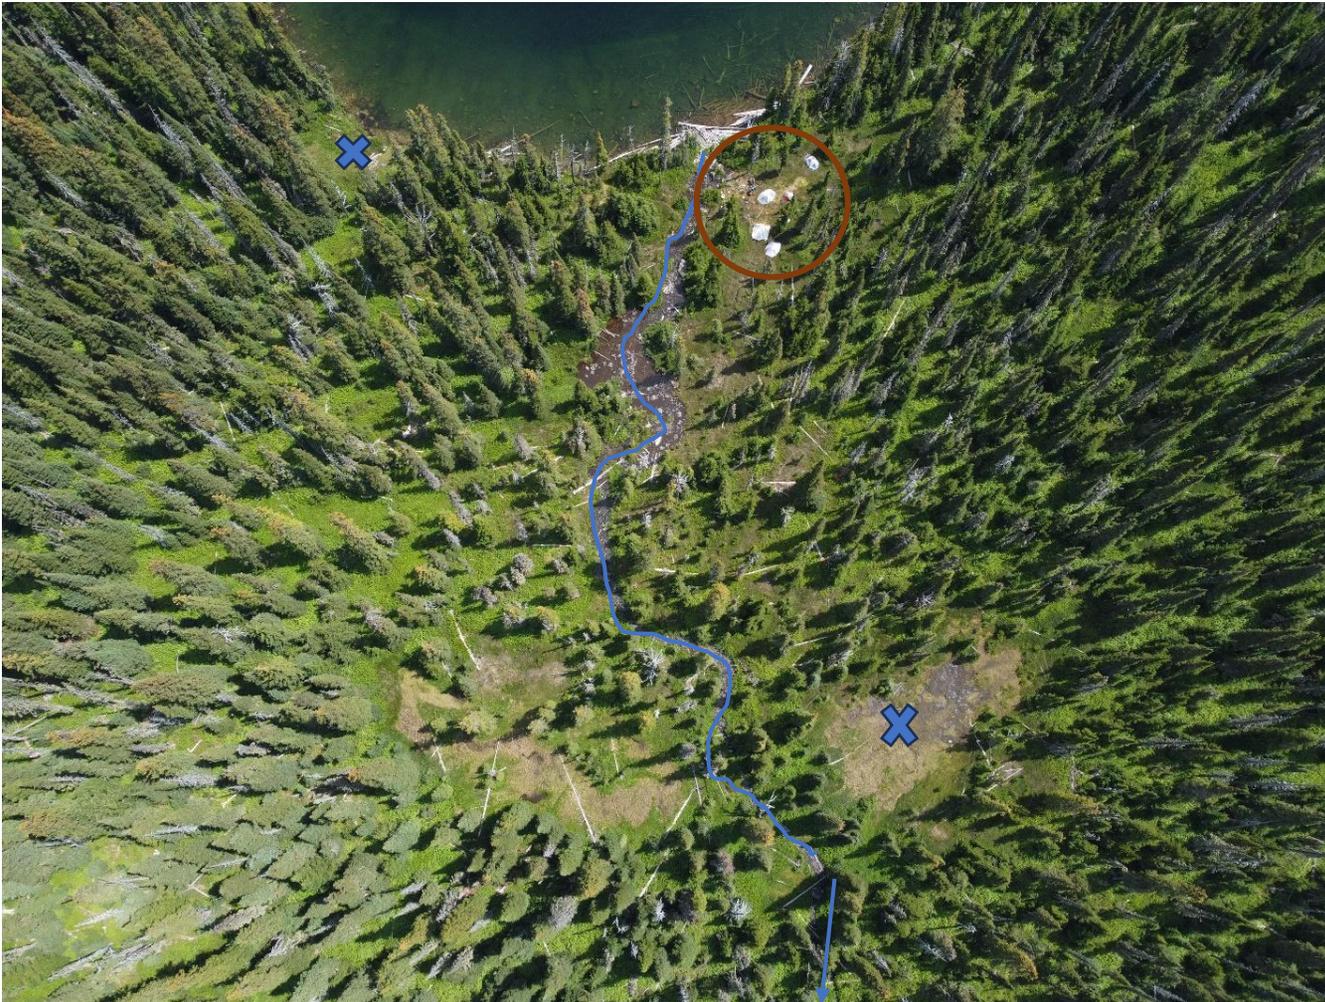
**Photo 18.** The outlet stream with approximate centreline drawn in blue. The outlet creek has high potential for trout spawning. The camp can be seen at the top. Helicopter landing areas are indicated with an X.

The outlet stream has several sections of good quality fish spawning habitat. There is a log jam at the outlet that could impede fish passage into and out of the outlet stream. Logs gathered at the outlet streams of natural lakes is typical and provides lots of cover for fish food. This is where many salamanders were observed.
