Nk'pux Lake  
Fish Potential Assessment  
2023 to 2025

Arsenault Environmental Consulting Ltd. (Arsenault) is pleased to provide the following summary report for a fisheries and NK'pux Lake health assessment to Kanaka Bar Indian Band (the Client). The services specifically relate to a lake condition assessment to determine the potential for the headwater lake (the Site) to support a food-fishery for members of the Kanaka Bar Indian Band. This program is intended to help community members to create a management plan for the creation of a sustainable fishery at the lake.

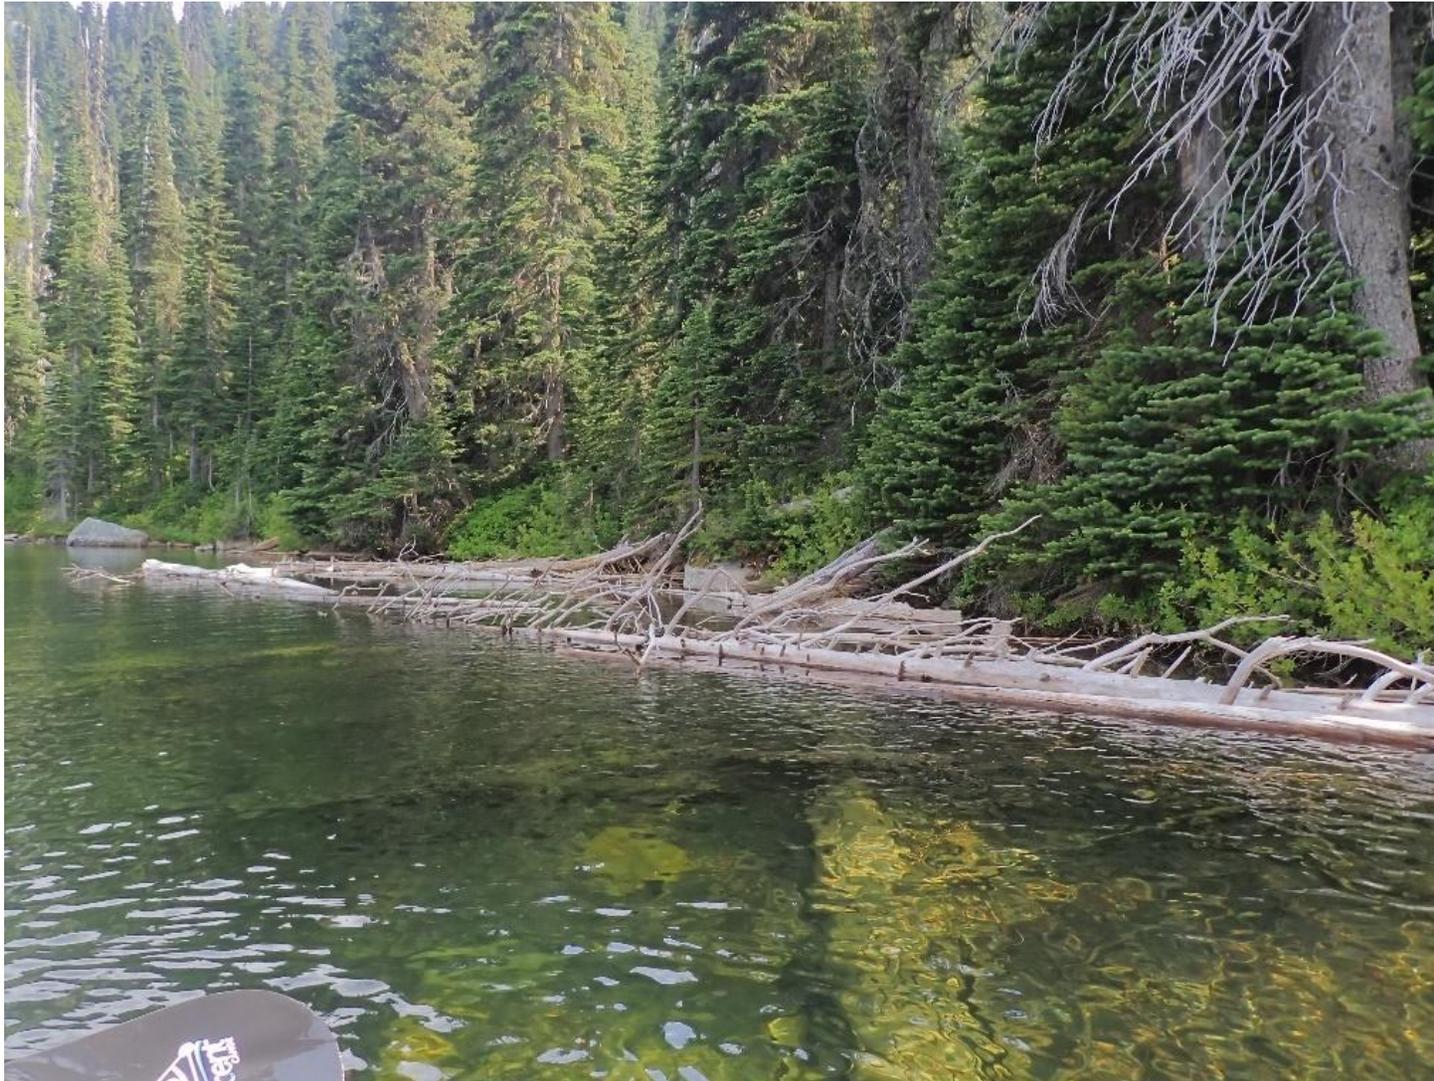
**Photo 20.** Logs are along this whole section, with gravel on the shoreline.

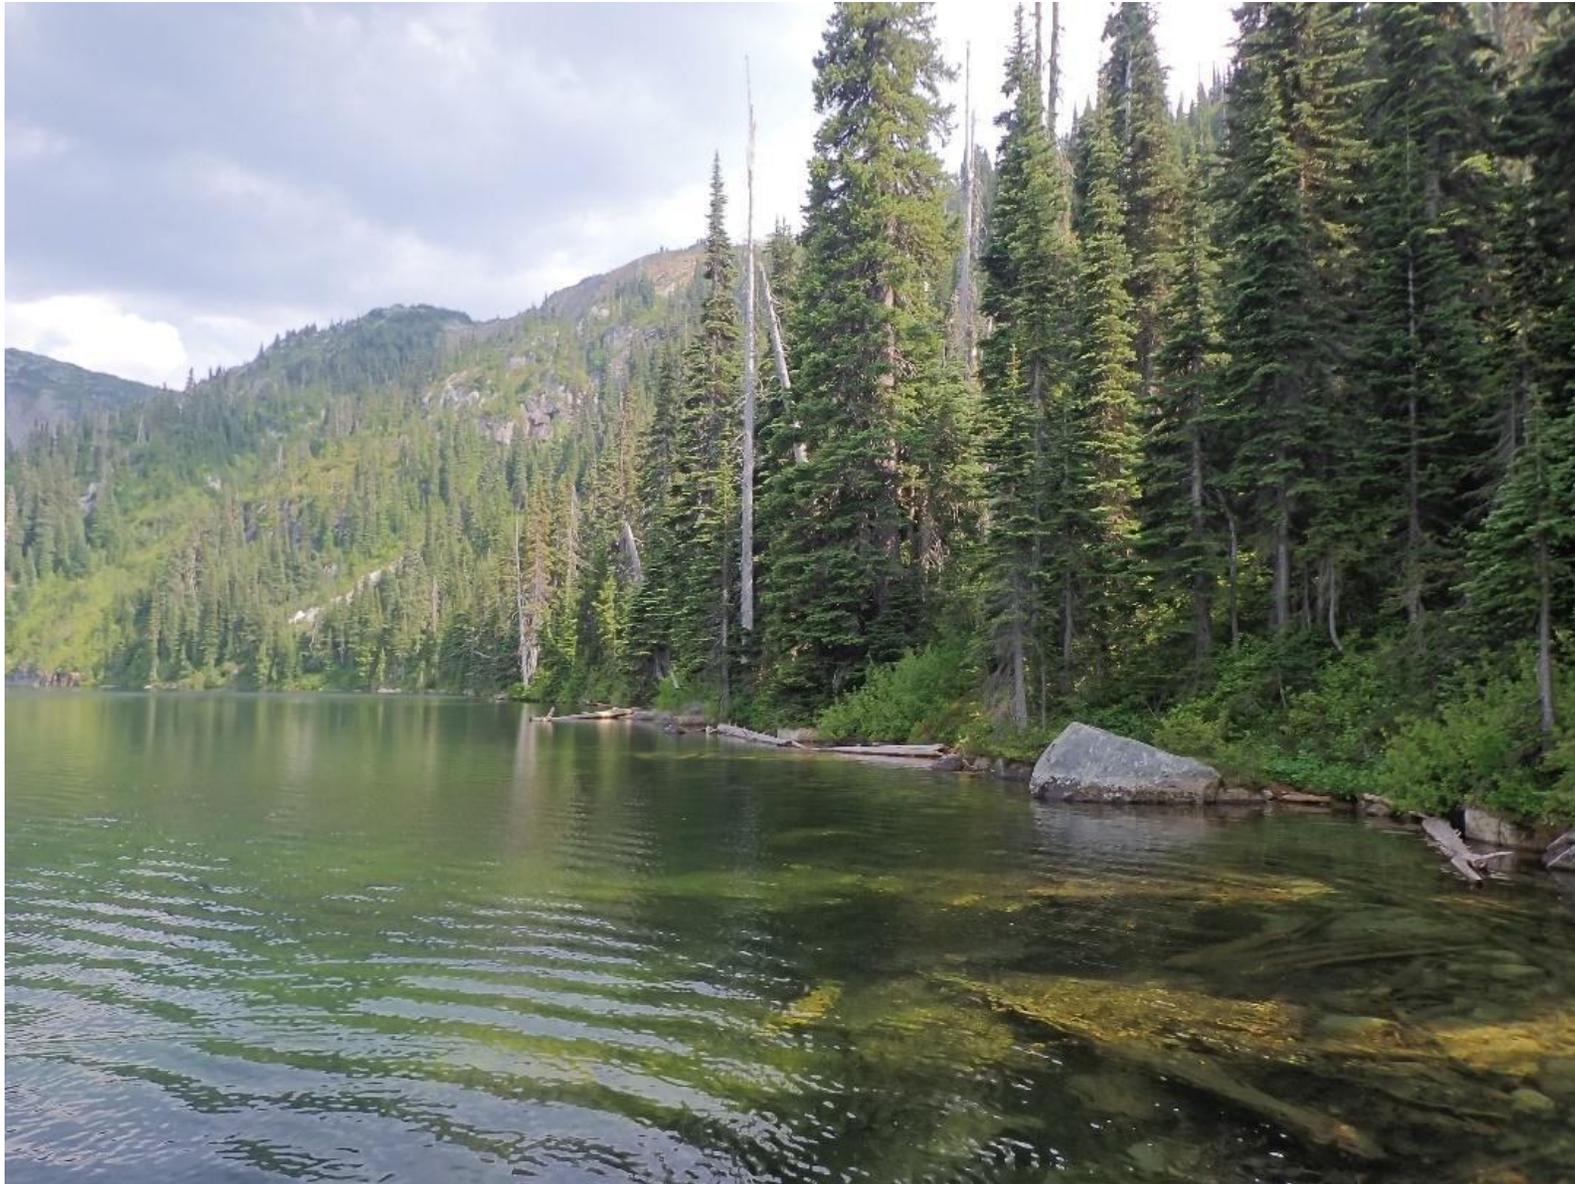
**Photo 21.** Zone 8 along the south shore has gravel and cobble with dispersed, sunken logs. Some pockets of potential shone spawning habitat.

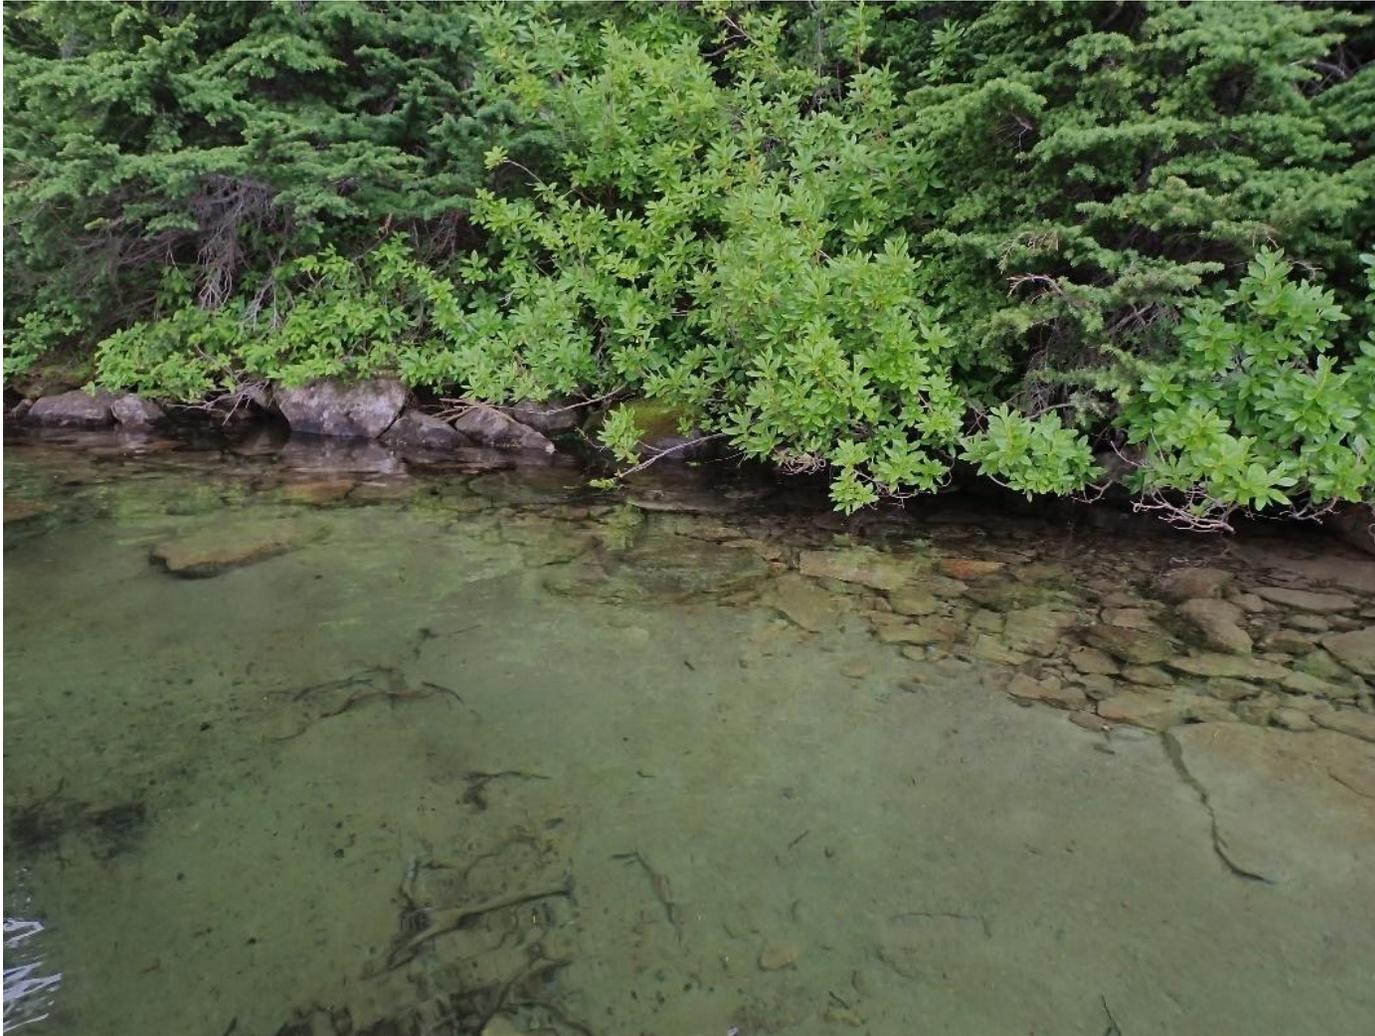
Zone 9 - Very Short Littoral zone, cobble, gravel and boulders on slope with lots of structure (boulders and logs), probably good fishing – negligible spawning potential

**Photo 24.** Typical habitat of Zone 9.

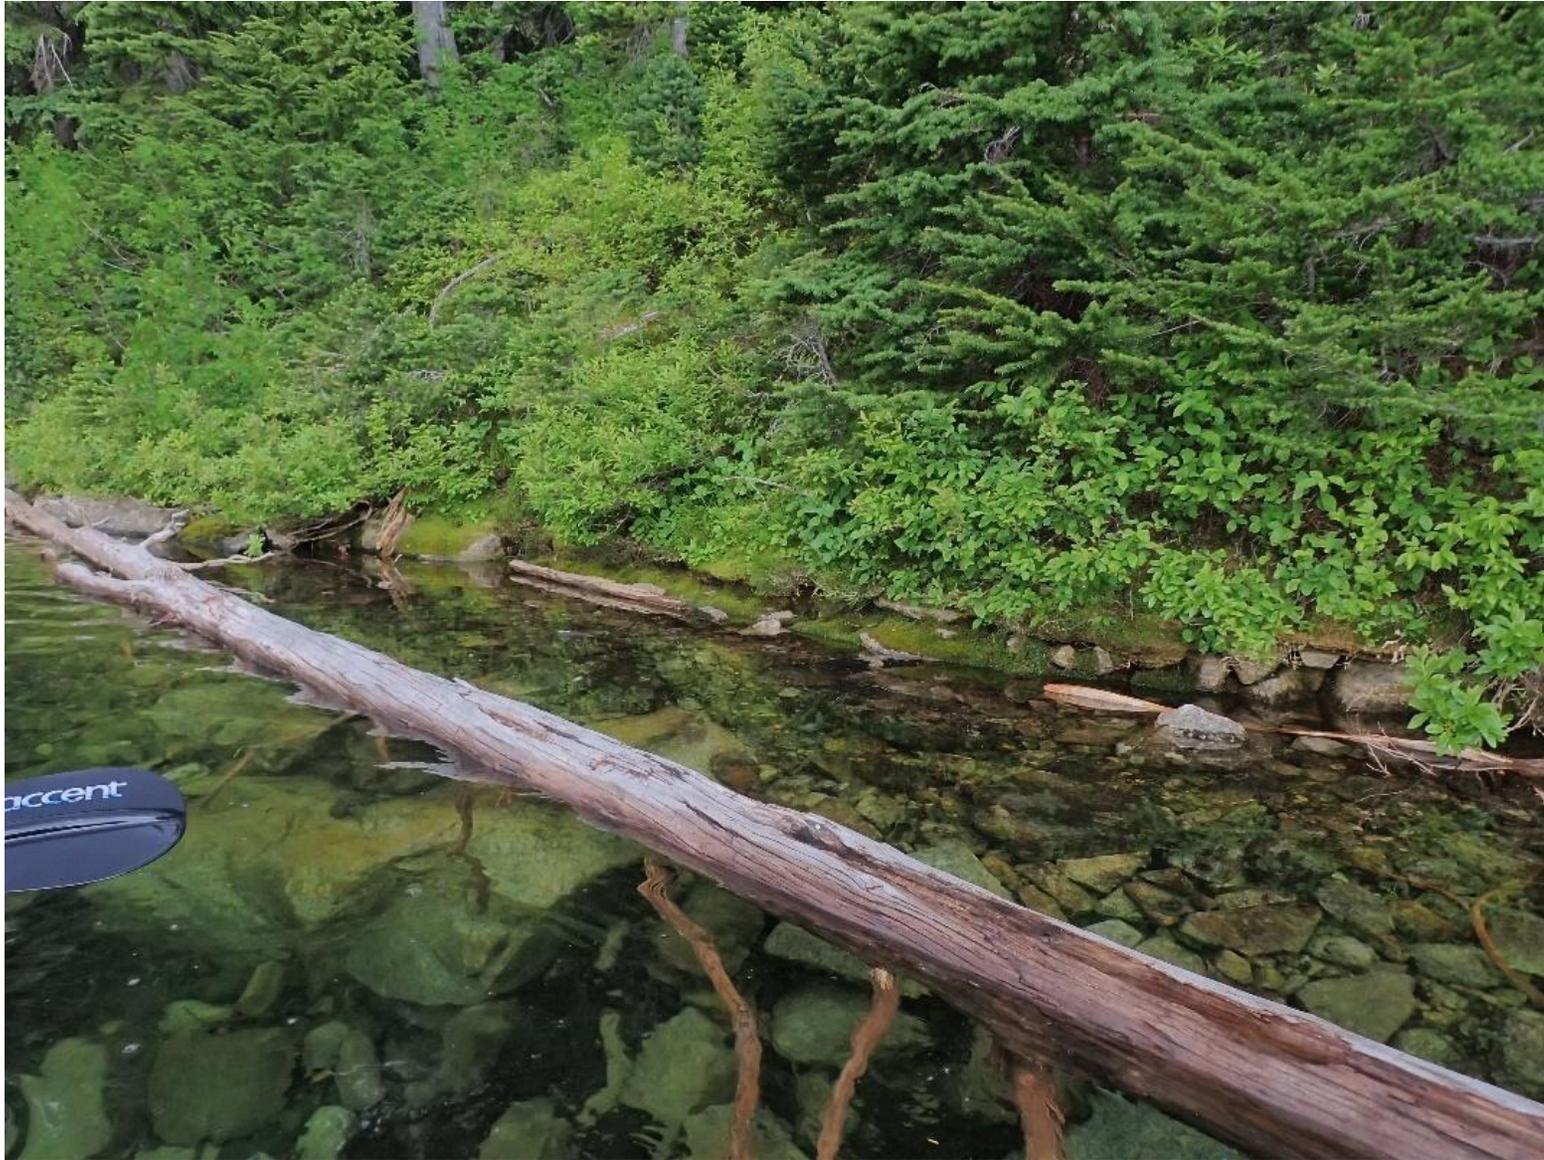
**Photo 27.** The east side of Zone 9. This part has spawning potential due to the gravel and cobble.

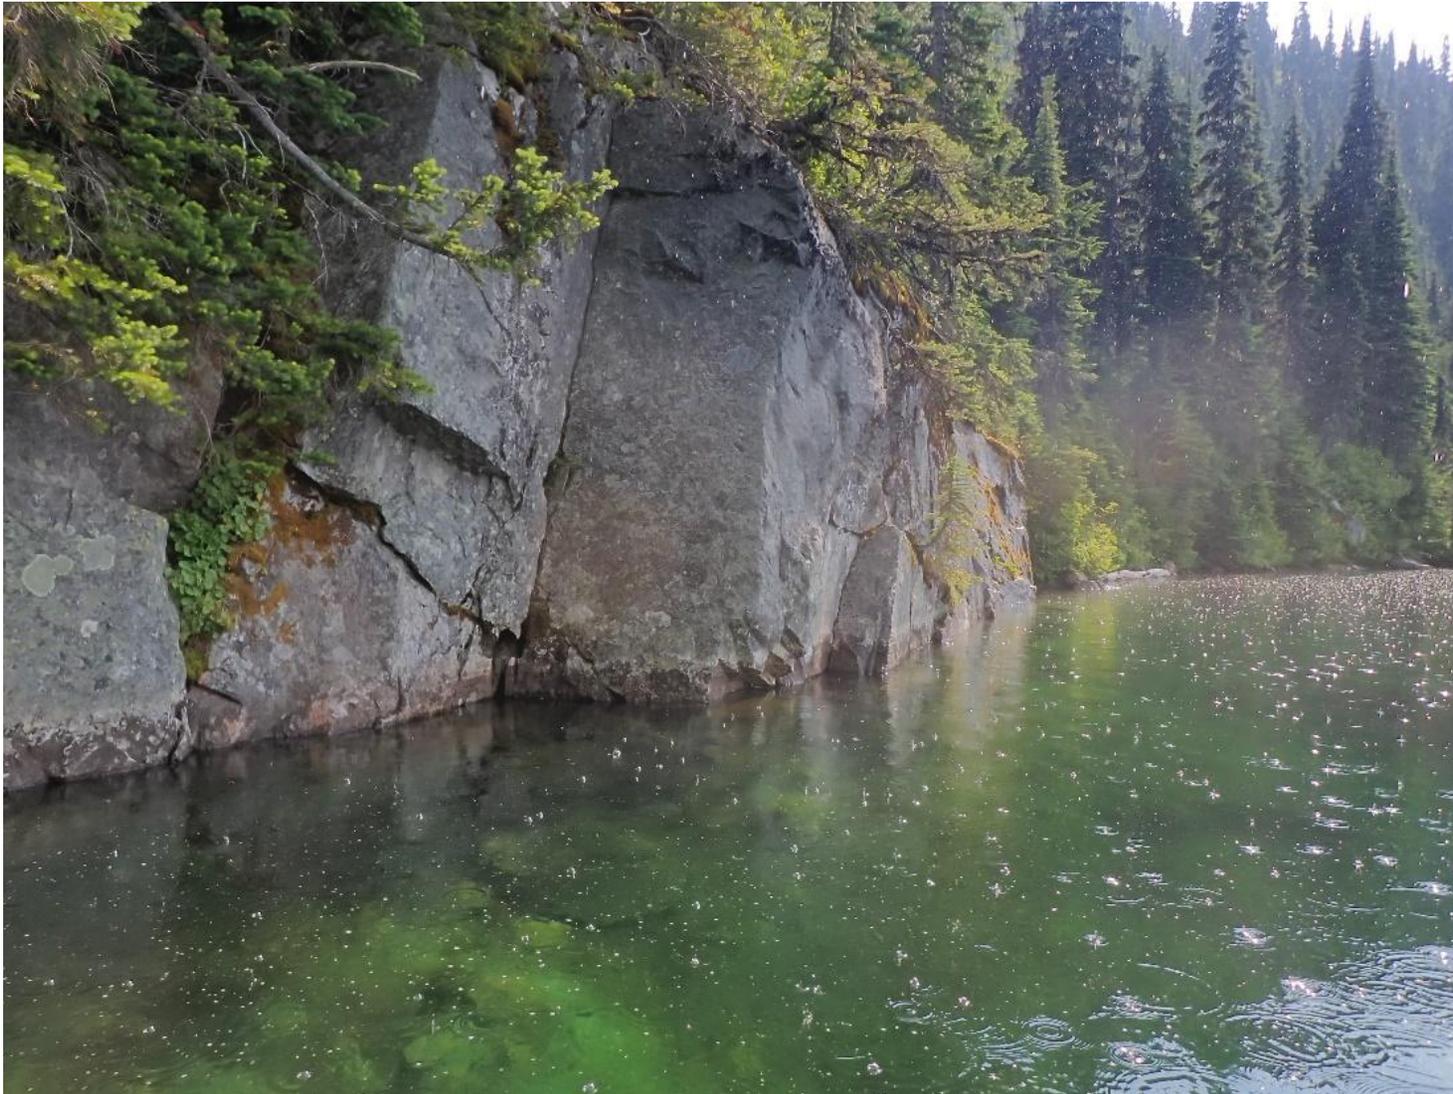
**Photo 28.** Potential for spawning with gravel patches. There is a steep drop off along Zone 10.

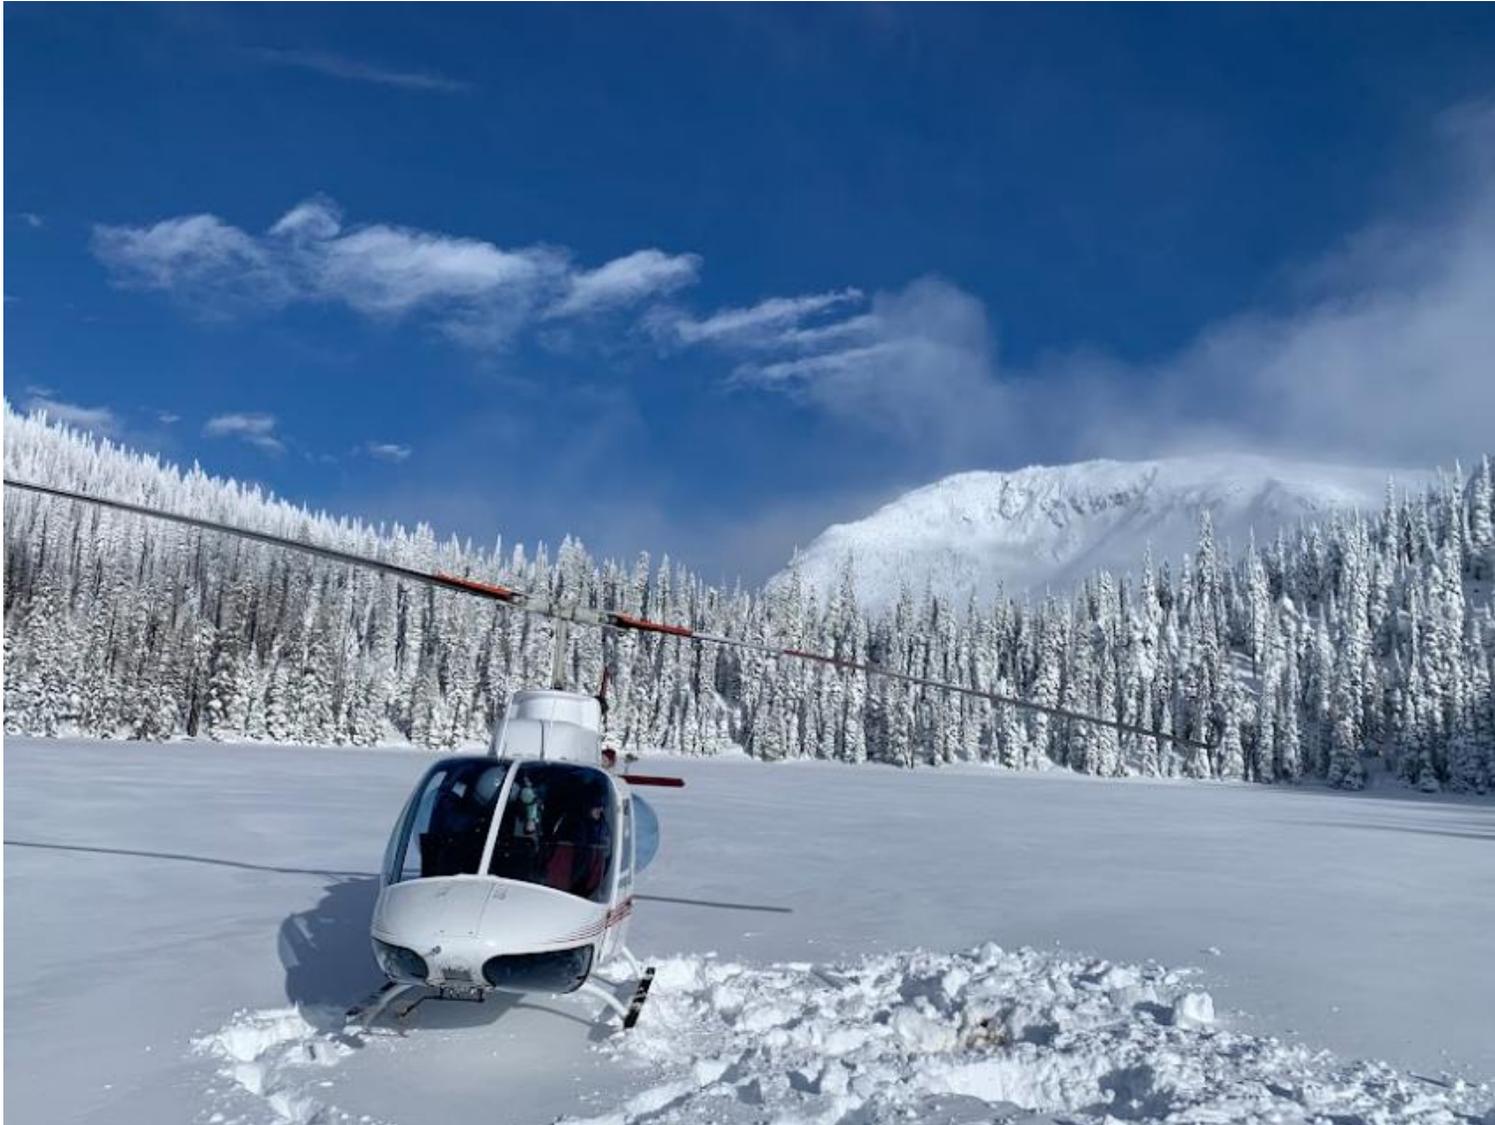
**Photo 36.** The helicopter landed on the ice on March 12, 2024. The snow depth was 80cm and the ice depth was 55cm. The hole was made right beside the helicopter due to running against time from the cloud cover closing in.

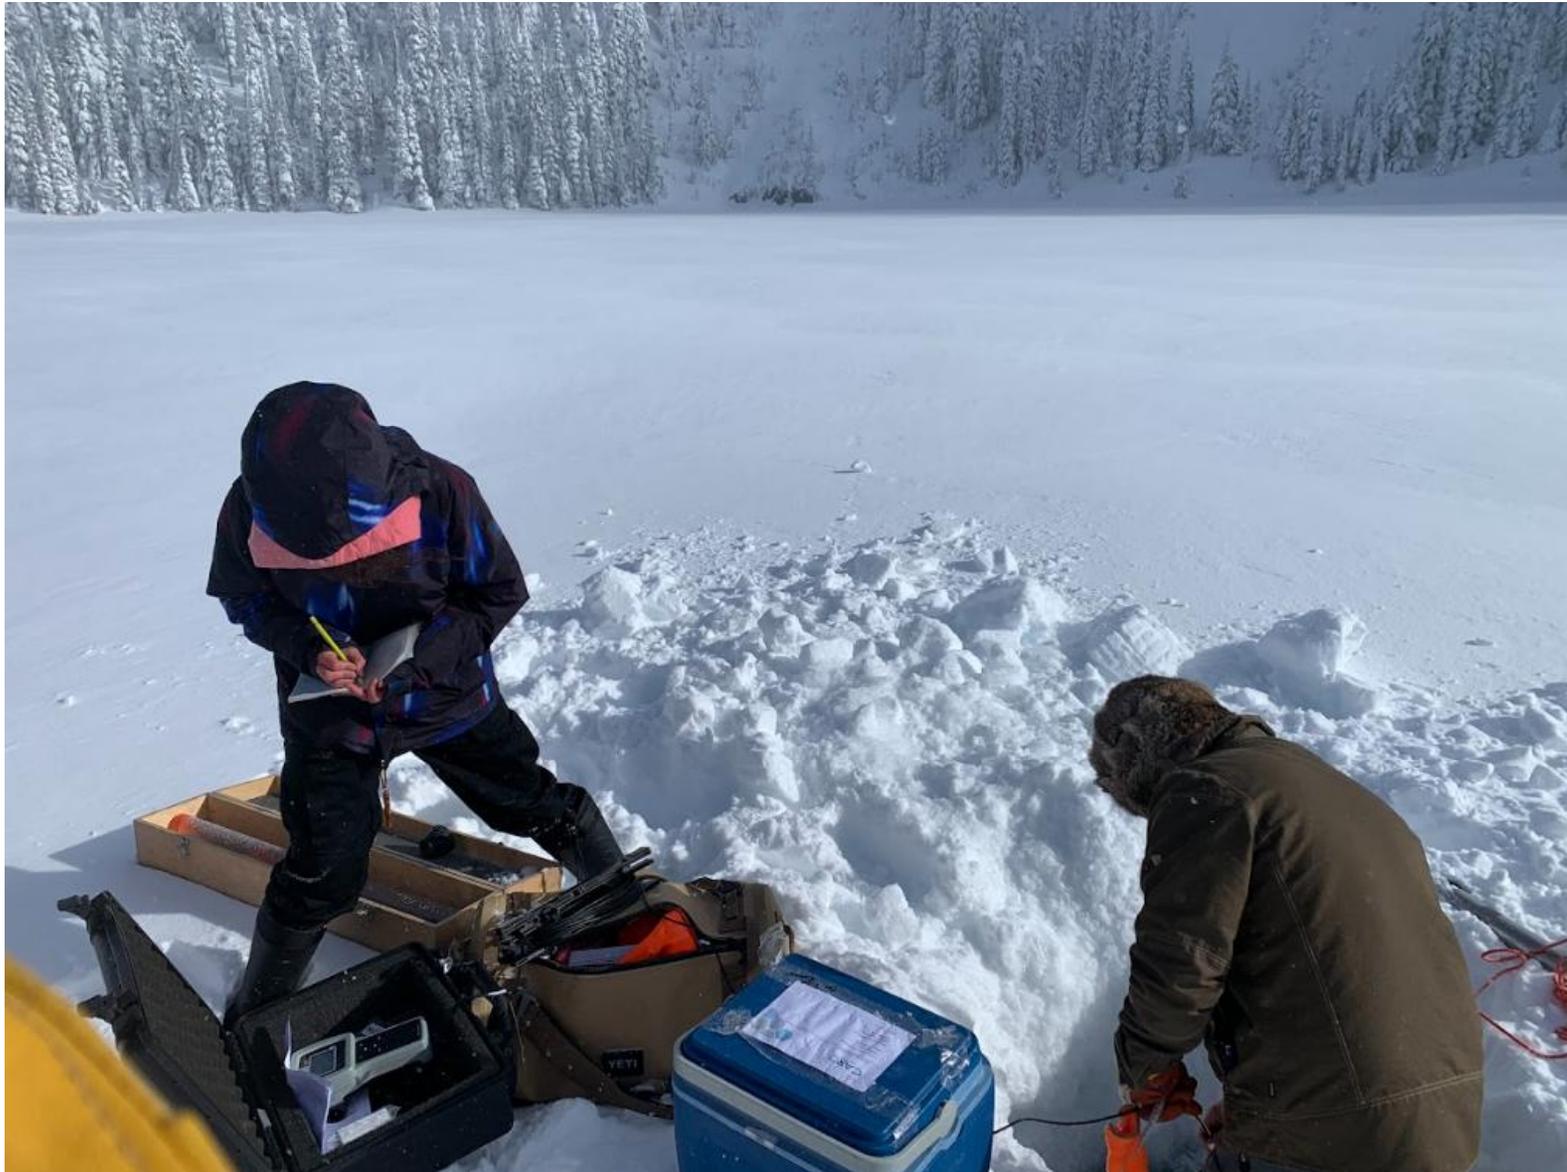
**Photo 38.** A look at the equipment used for sampling

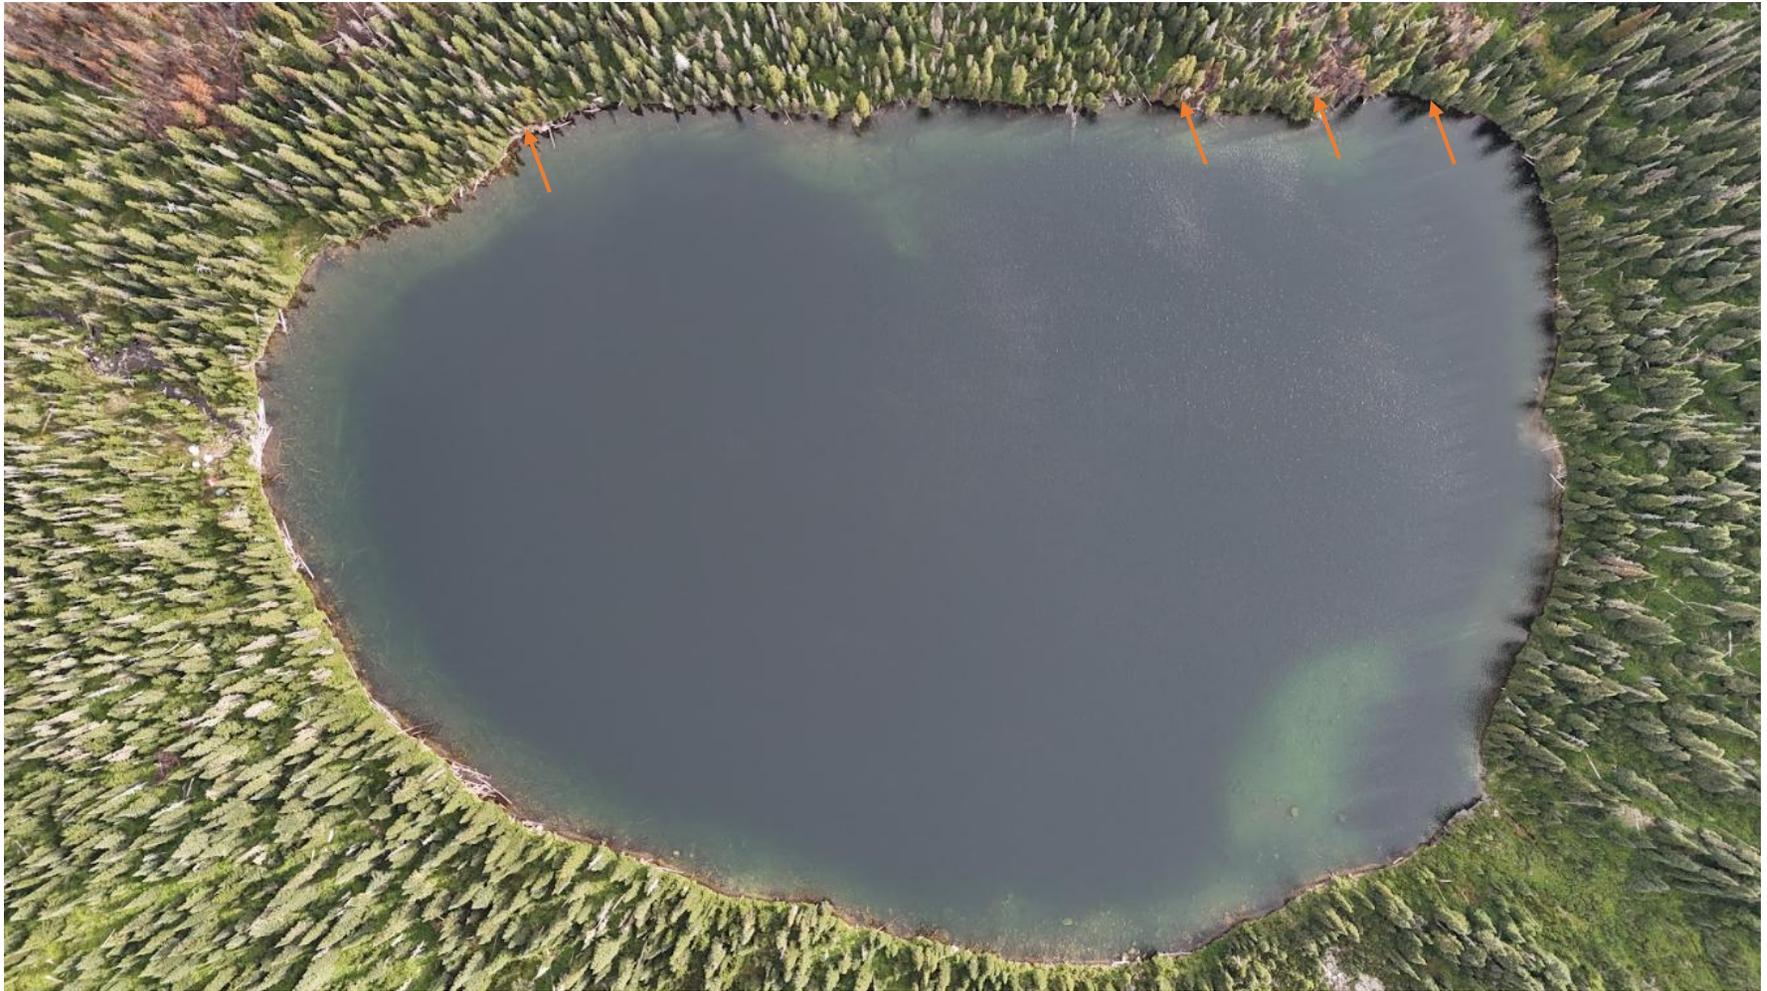
**Photo 39.** July 2024 - The fire touched four places on the north shore of Nk'Pux Lake, the largest about 12 meters wide (others 3 meters).

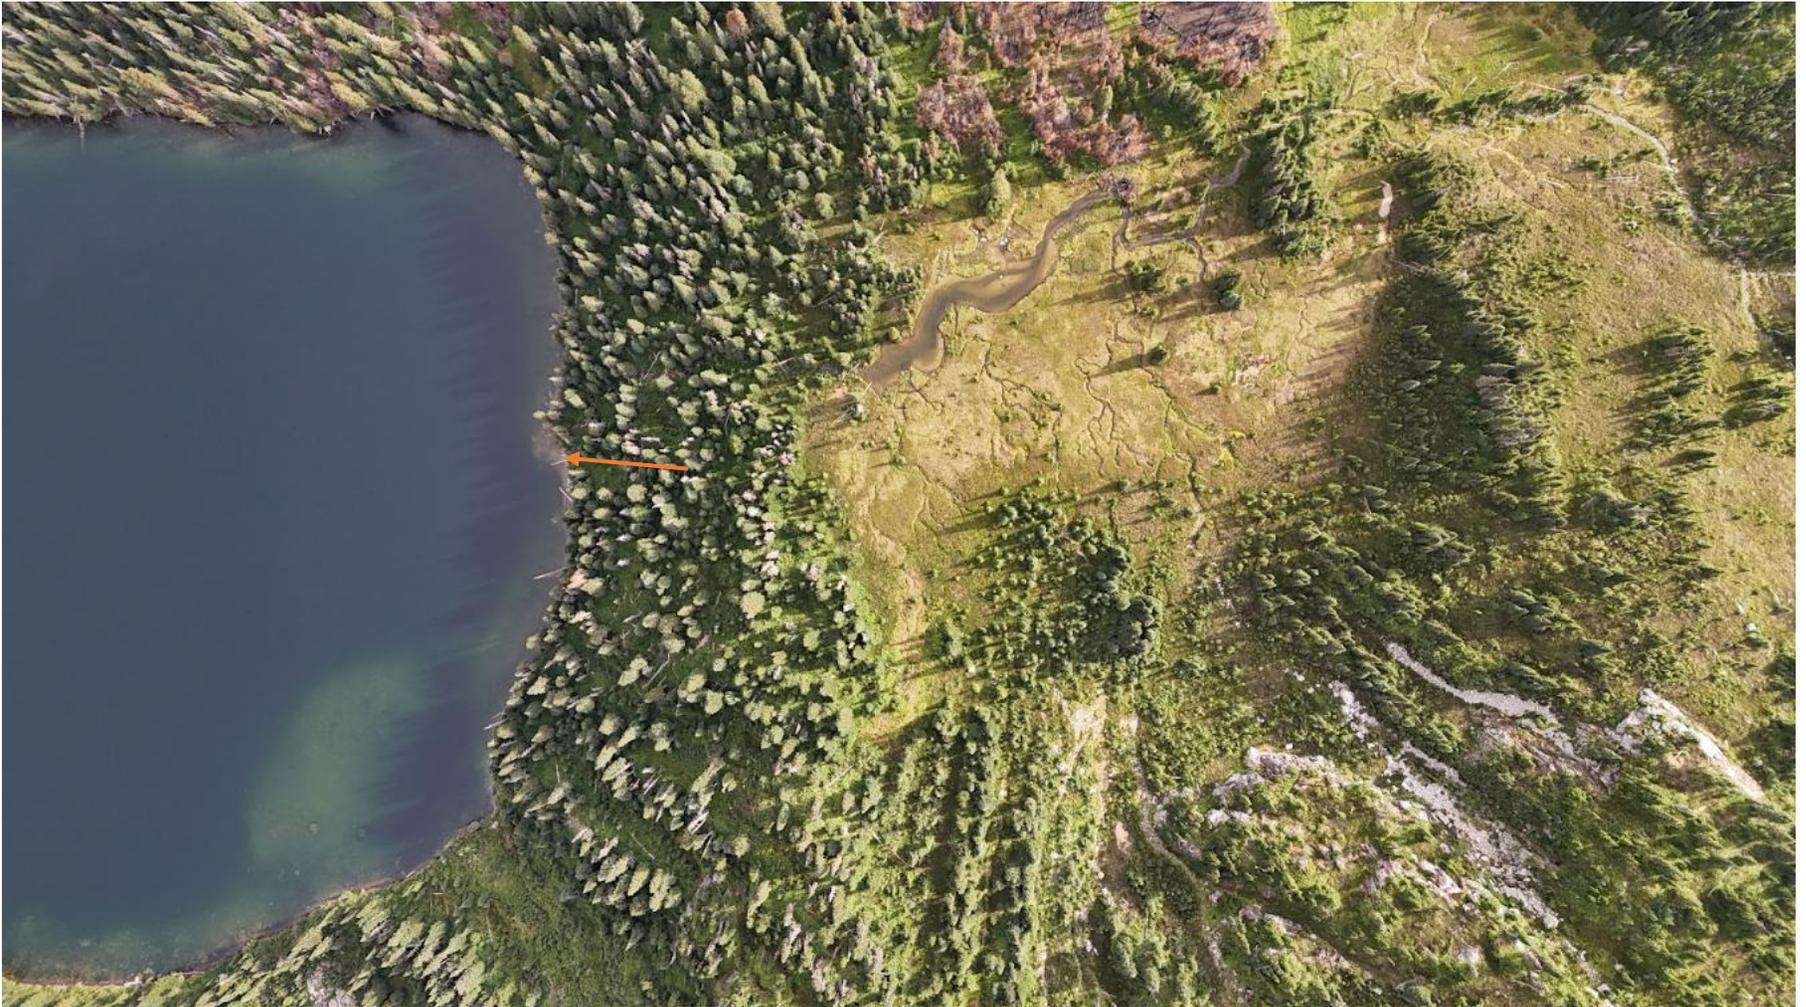
**Photo 42.** The inlet creek of Nk'pux Lake goes through a wetland before going down a steep slope and into the lake (arrow)- July 2024

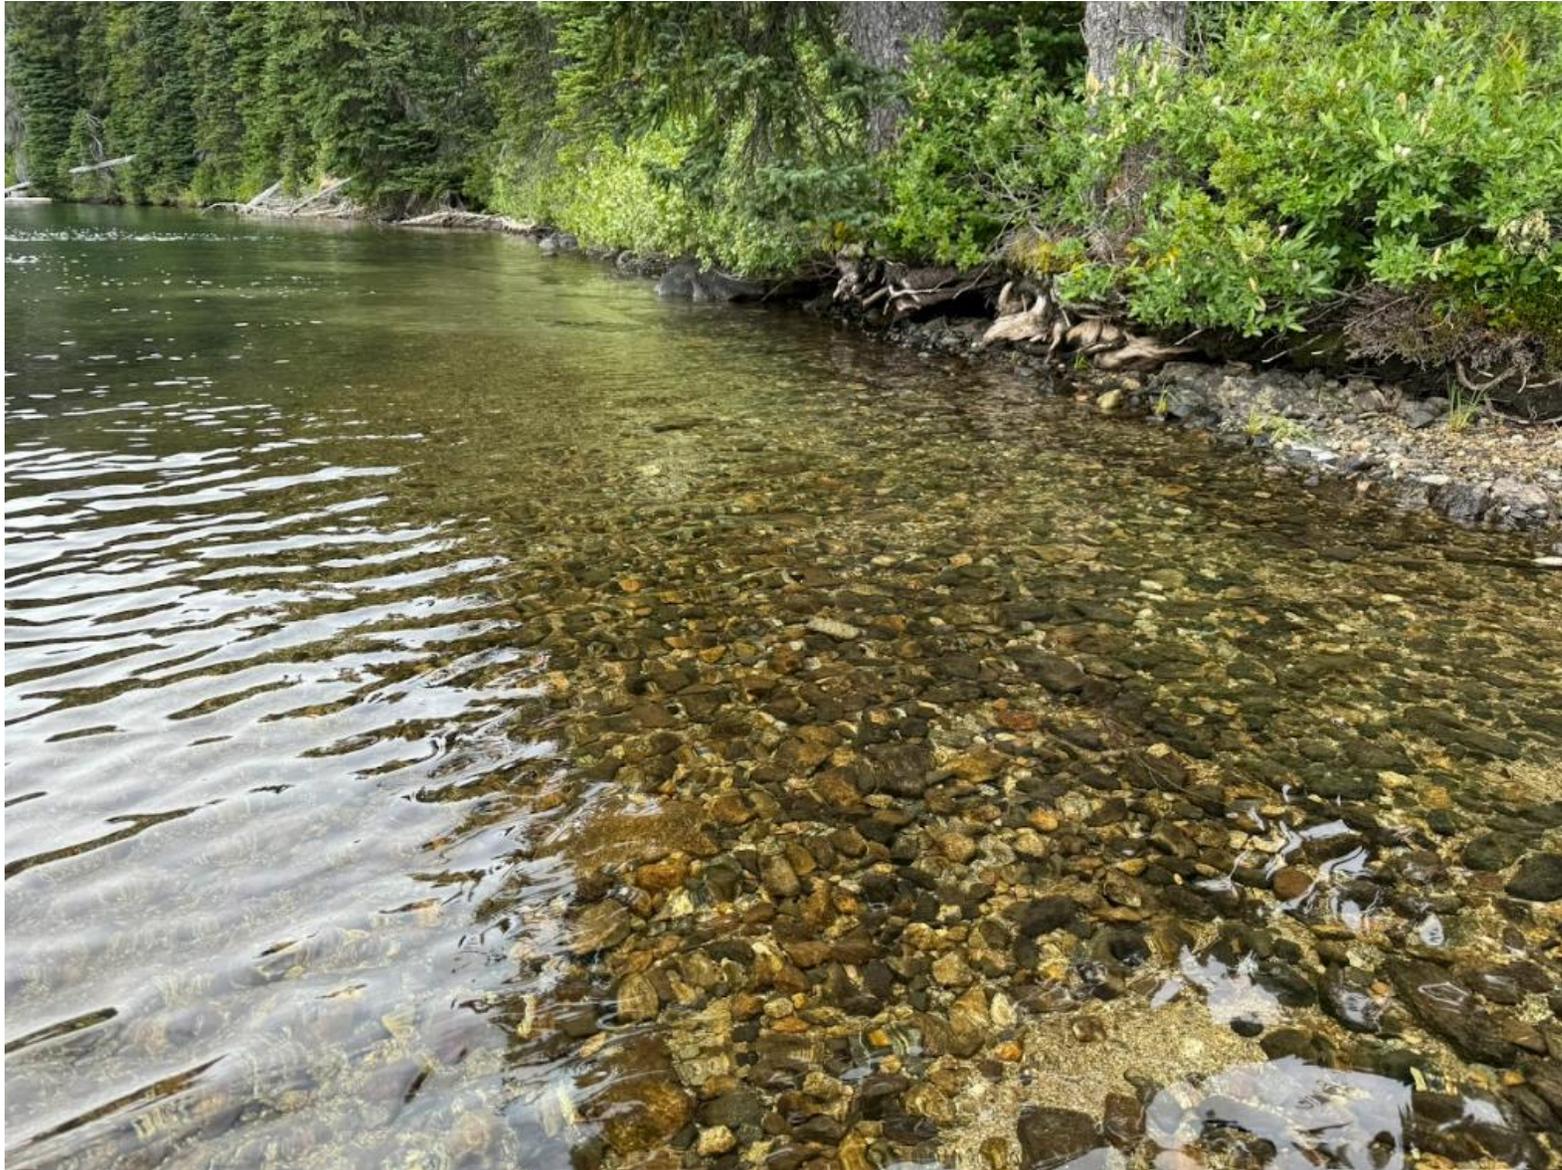
**Photo 43.** Potential fish spawning habitat beside the inlet stream. Benthic invertebrates were collected from here – July 2024

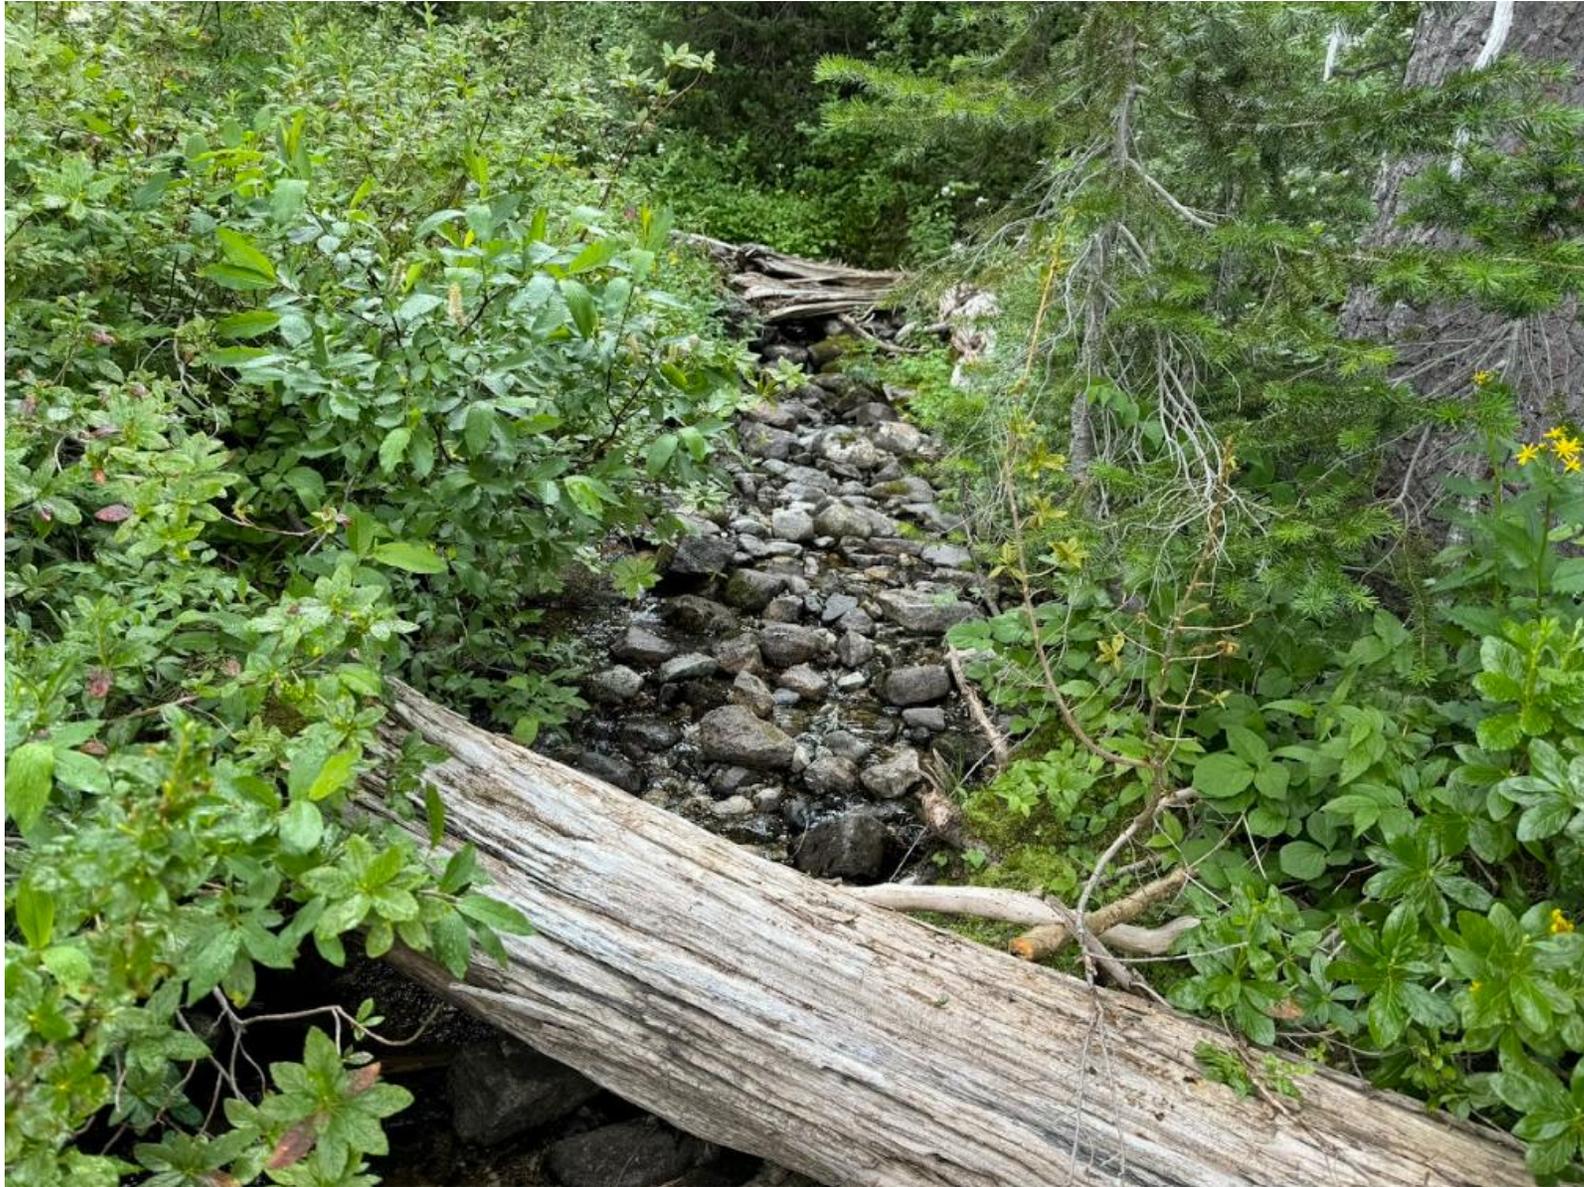
**Photo 45.** Creek inlet facing upstream. This area could be enhanced to improve fish spawning habitat – July 2024

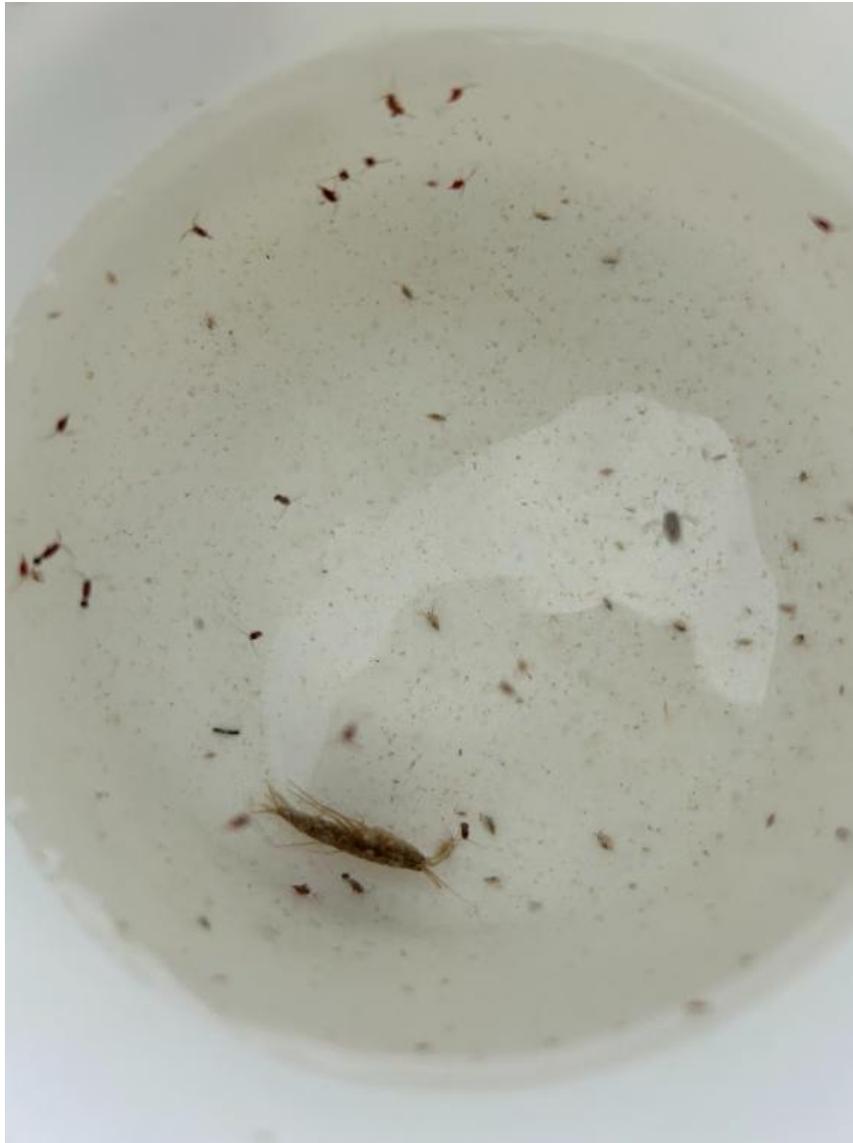
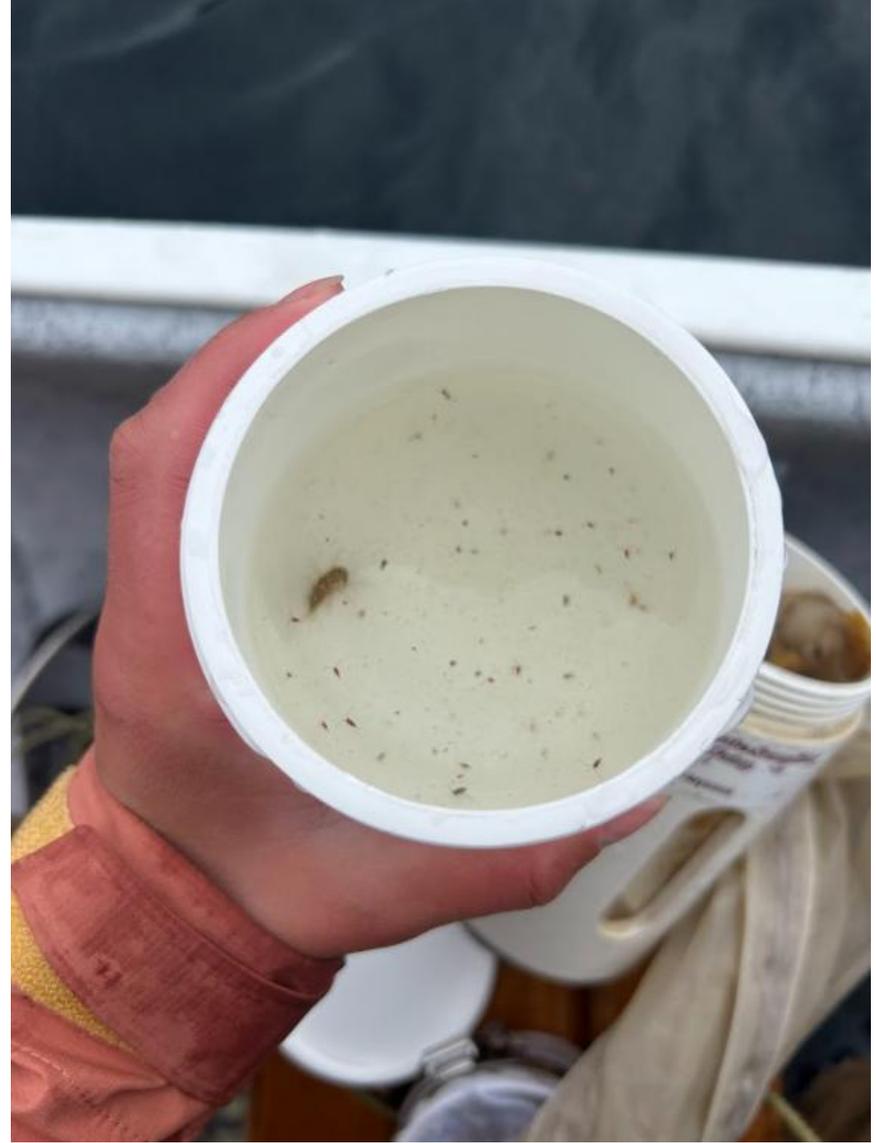
**Photos 47 & 48.** Zooplankton sample July 2024. Shrimp, rotifers and water fleas. Sampling equipment used for zooplankton is seen in the background.
