Nk'pux Lake  
Fish Potential Assessment  
2023 to 2025

Arsenault Environmental Consulting Ltd. (Arsenault) is pleased to provide the following summary report for a fisheries and NK'pux Lake health assessment to Kanaka Bar Indian Band (the Client). The services specifically relate to a lake condition assessment to determine the potential for the headwater lake (the Site) to support a food-fishery for members of the Kanaka Bar Indian Band. This program is intended to help community members to create a management plan for the creation of a sustainable fishery at the lake.

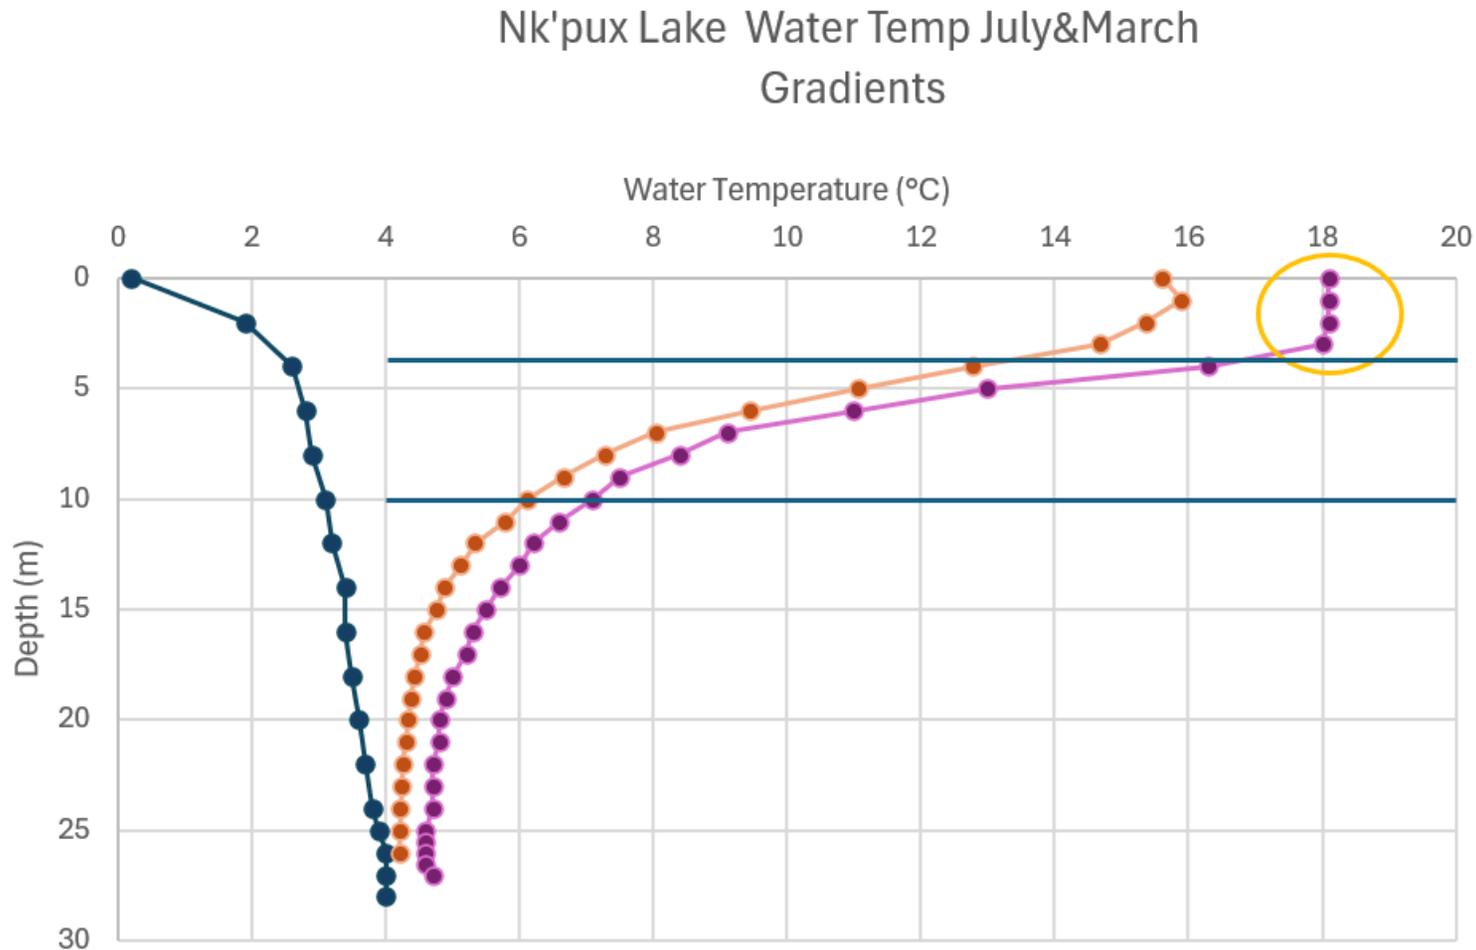
**Figure B1.** Nk'Pux Lake water temperature Gradient at the deepest part of the lake for Summer July 2023 (Orange), Winter March 2024 (Dark Blue) and Summer July 2024 (Magenta). Between the solid blue lines is the thermocline. A thermocline is where the temperature changes rapidly from warmer at the surface to colder in the depths and really only applies in the summer. The thermocline at this spot in the lake starts around 4 meters shown with the top solid blue line. The yellow circle shows that the temperature stays the same for the first 4 meters, this is partially due to the natural heat from the sun warming the surface of the lake. As for rainbow trout, they can survive between 0-29.8°C and perform optimally between 10-18°C (Jiang et al. 2021)(Molony 2001).

Dissolved oxygen and temperature were successfully measured at the deepest point in the lake in Summer 2024 and Winter 2024. The temperature is not irregular, and the DO gradient is as expected. The bottom of the lake stays at around 4°C all year. Water is most dense at 4°C. In winter, the surface of the water stays at close to 0°C. In the summer, the top of the water is warmest and at about 4m, the water temperature drops rapidly. This is called the thermocline. Rainbow trout prefer a temperature between 7-18°C with their upper lethal temperature being 28°C (Ineno *et al.* 2020). Colder water can hold more oxygen. This means that in the

winter, water closer to the surface has more oxygen as it is colder. More dissolved oxygen means more oxygen available for the fish to use. In the summer, the higher dissolved oxygen layer is in the thermocline. In the summer, the dissolved oxygen level at the surface is lower due to high temperatures allowing water to release oxygen into the air decreasing the amount of oxygen in the water. These data are shown in graphs in Appendix B, Figure B1, Figure B2, and Figure B3.

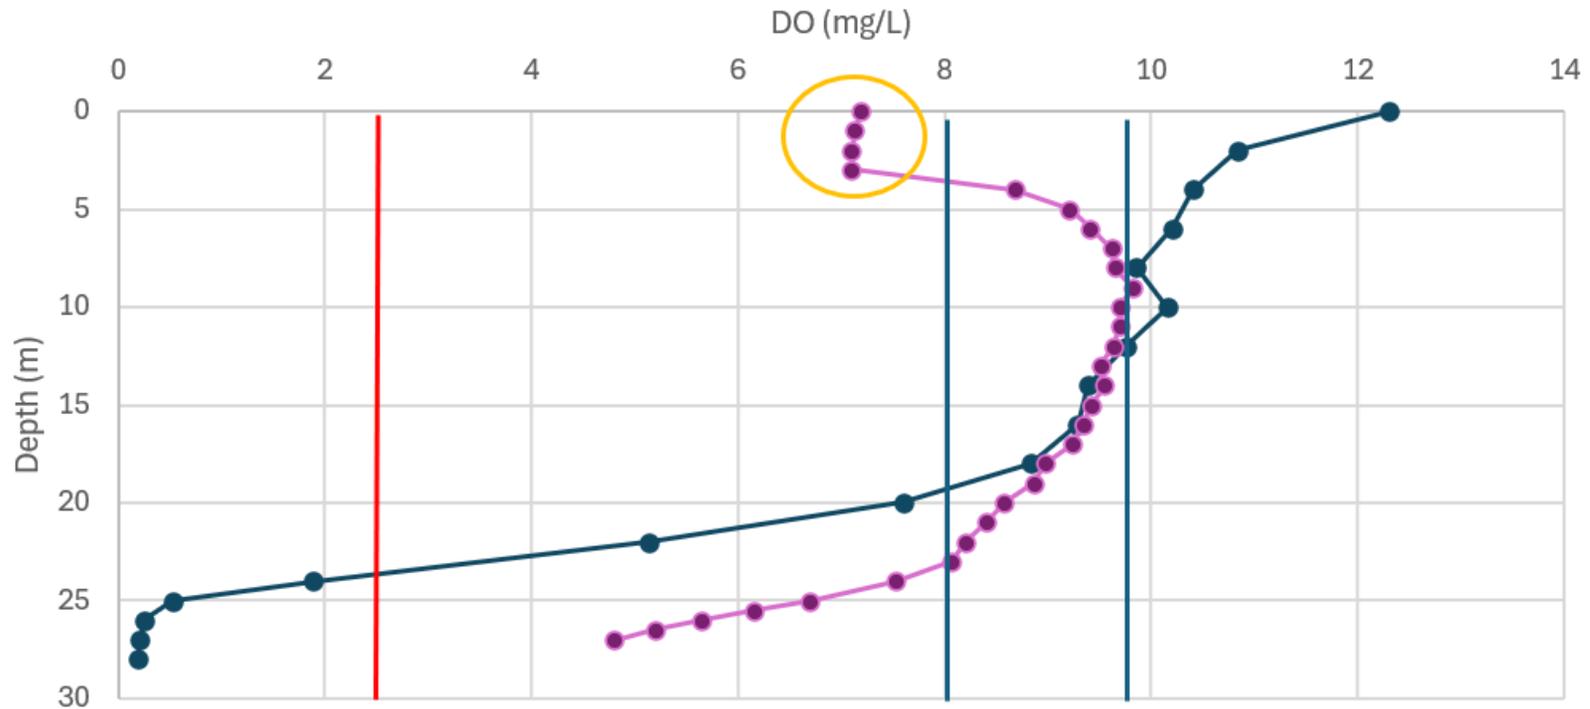
### Nk'Pux Lake Spring 2024 DO Gradients

**Figure B2.** Nk'Pux Lake Dissolved Oxygen gradient at the deepest point in the lake, Winter March 2024 (Dark Blue) and Summer July 2024 (Magenta). Rainbow trout need above 2.5 mg/L of Dissolved Oxygen in water to survive, which is shown by the red line, meaning that in the winter the rainbows will stay above a depth of 24m (Swales 2006). The yellow circle shows where the higher temperature at the surface releases the oxygen into the air equalizing the oxygen level in air and water. This explains the decrease in dissolved oxygen at the surface.

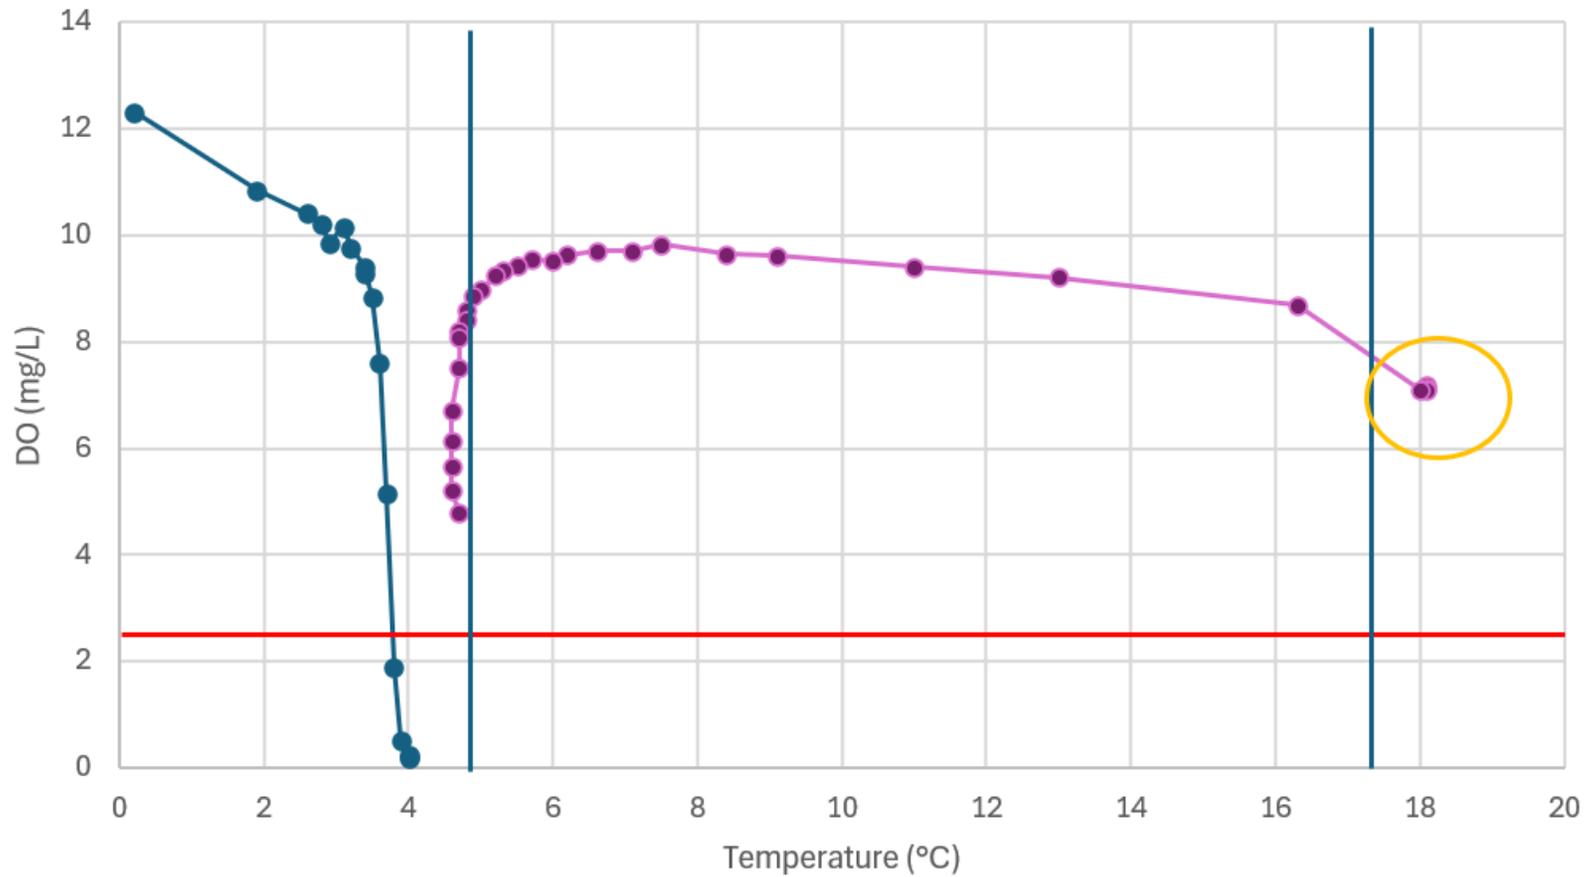
### Water Temperature Vs Dissolved Oxygen Availability

**Figure B3.** Blue is winter, magenta is summer 2024. Temperature is a variable that determines the dissolved oxygen levels in water. If there are no other variables than temperature, the data would have a negative relationship, that is a descending line, meaning the lower the temperature the higher the Dissolved Oxygen levels. The yellow circle shows where the higher temperature at the surface releases the oxygen into the air equalizing the oxygen level in air and water. This explains the decrease in dissolved oxygen at the surface.
