POST-WILDFIRE GEOTECHNICAL HAZARD ASSESSMENT

Kanaka Bar Reserve

Project Number: 23-179

November 21, 2023

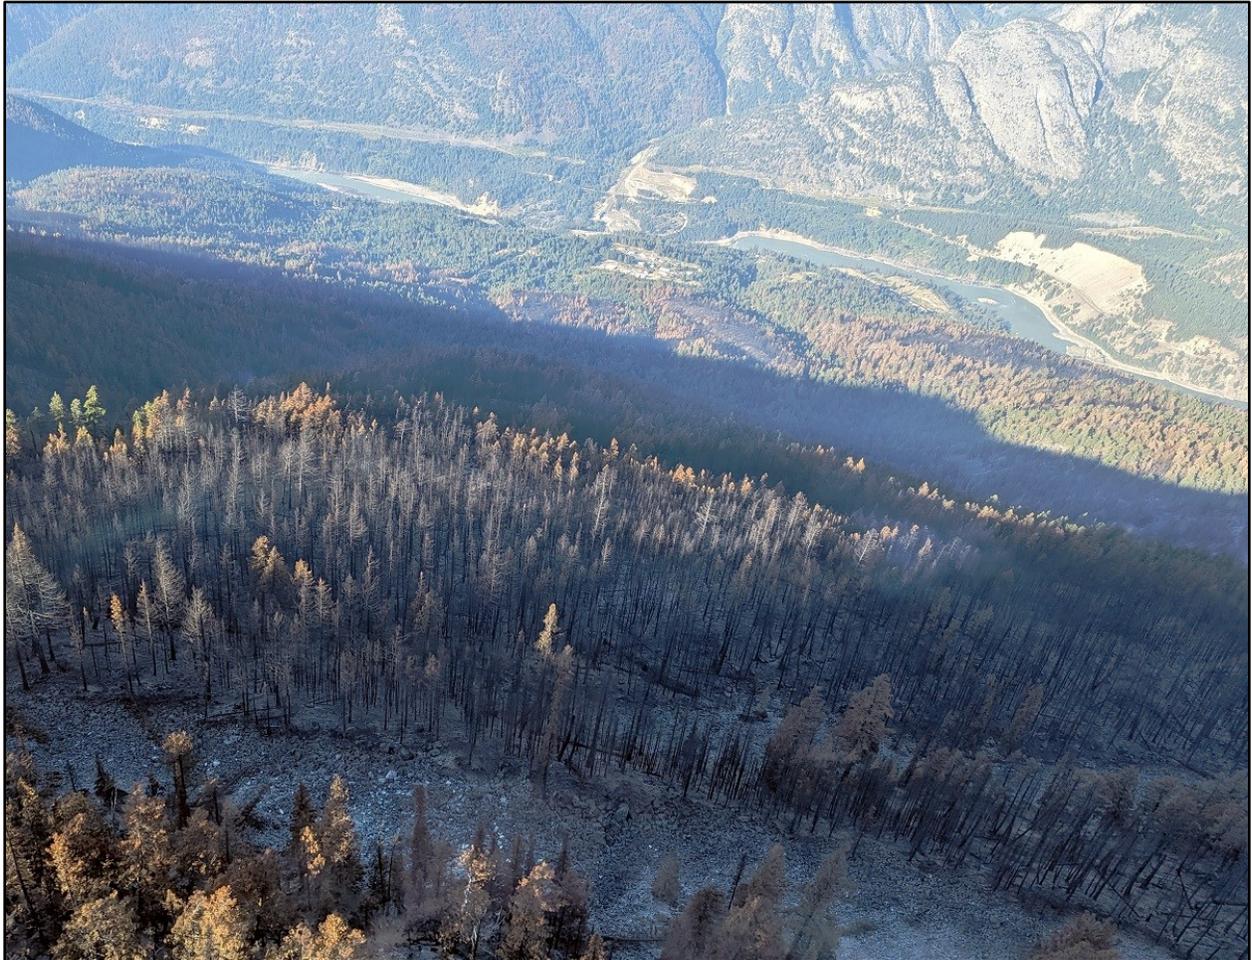
Photo 1: Fire mosaic above reserve.

The Kookipi wildfire (V11337) started in Kookipi Creek south of Nahatlatch River in early July 2023. In late August 2023, driven by warm temperatures and strong southwesterly winds, it greatly expanded in size, crossed Fraser River, and then burned forests to the north. All of the terrain upslope of the reserve up to the height of land was burned, at variable intensities (Photo 1, Appendix 2). The final mapped area of the fire was 17,406 ha.

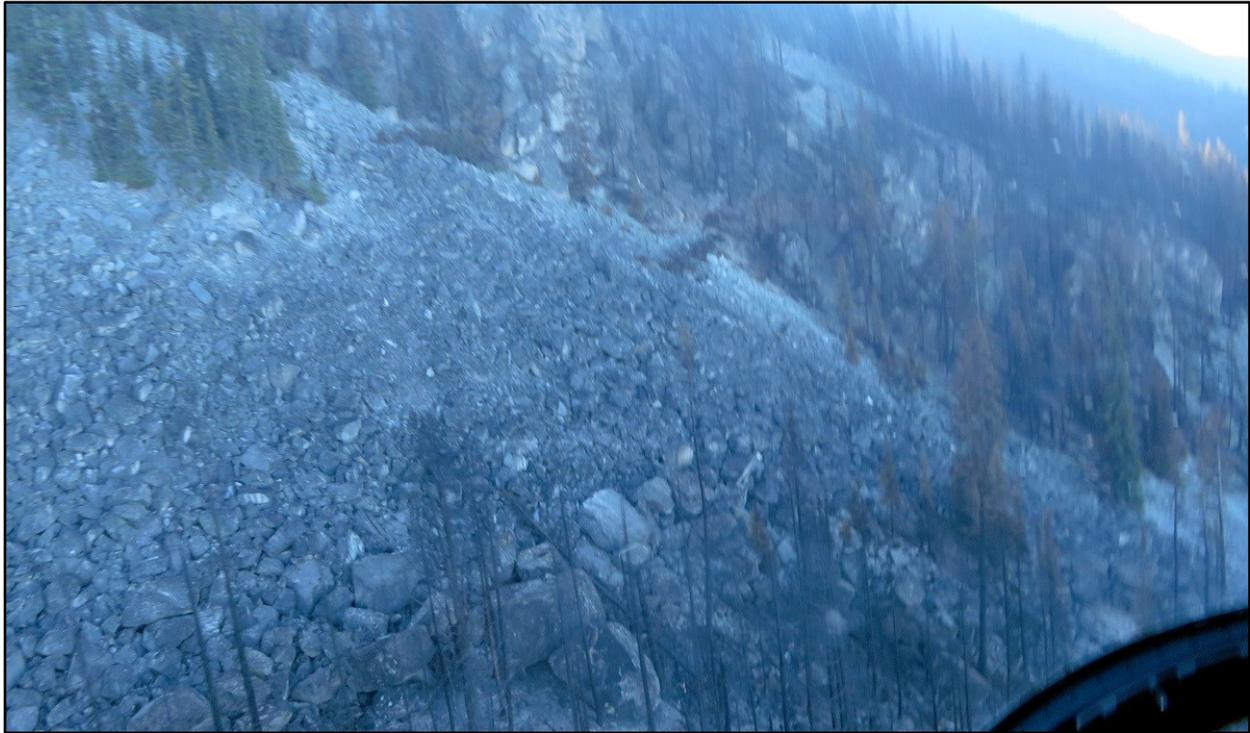
Photo 2: Large boulders in talus patches.

Evidence of geotechnical instability that we noted during the helicopter overflight consisted of extensive talus patches below bluffs, with boulders of up to 5 m in diameter (Photo 2). Talus patches are scattered in upper Nekliptum Creek and Niger Creek watershed, whereas in the headwaters of Morneylun Creek and Siwash Creek, the talus patches are more extensive and overlap the stream channels in the valley bottoms of these drainages. The November 2021 debris flow in Siwash Creek appeared to have initiated when high streamflow mobilized some of this talus in the stream channel, rather than initiating from a specific sideslope landslide that became a debris flow when it reached the channel.

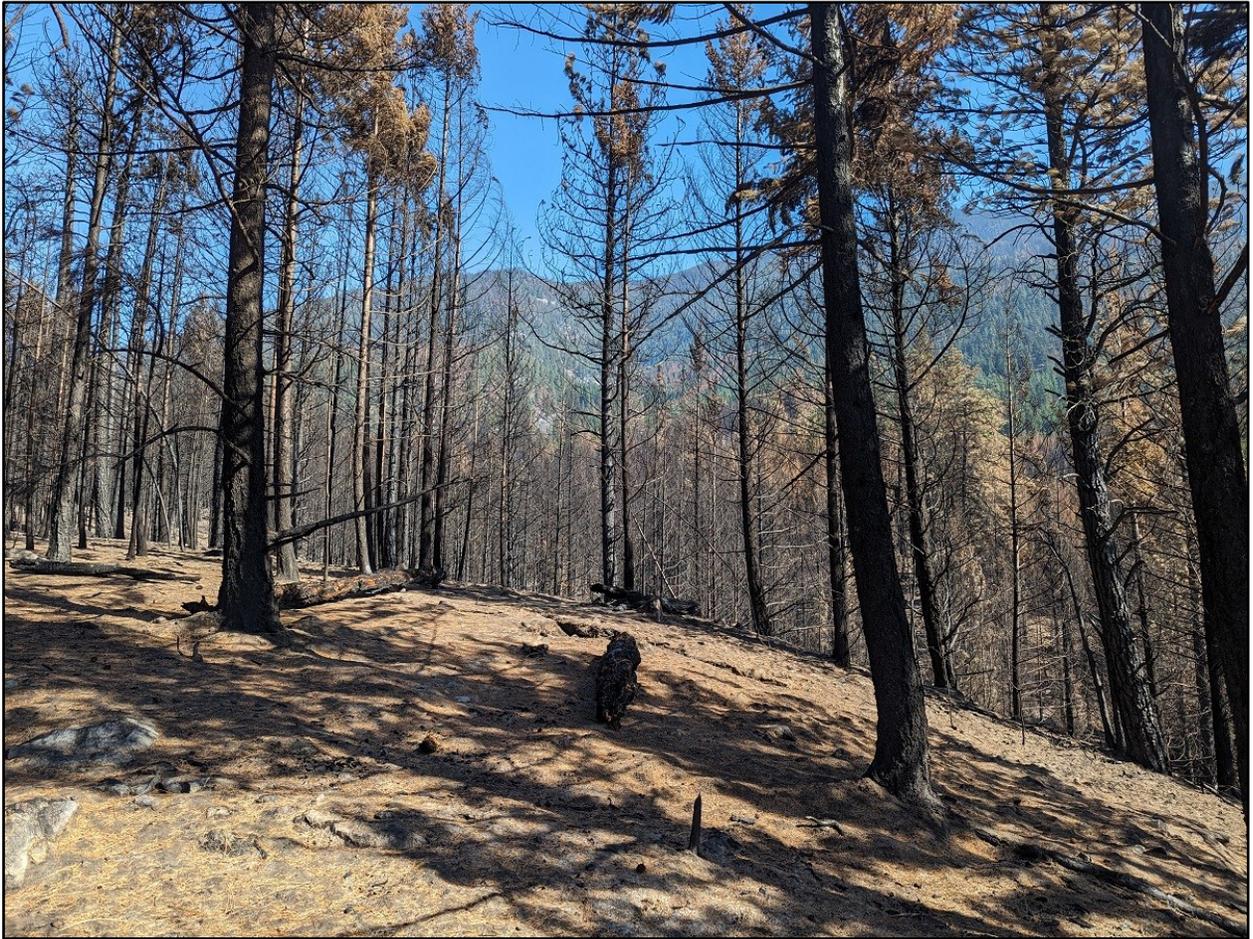
Photo 3: High intensity soil burn North Nekliptum above water intake.

Floods, debris floods, and debris flows in North Nekliptum Creek could also affect the community water supply. Sedimentation from any of these events, either during or after such an event, could damage or block the water intake. Sediment that reached the treatment plant, either by flowing overland, or by being carried down the water pipe to the interior of the plant, could also damage the treatment plant infrastructure or the plant itself. Given the high intensity of the ground fire in the drainage of North Nekliptum Creek upstream of the plant, and the consequent increase in sediment availability, it is also likely that sediment concentrations in the stream will increase significantly even at flow levels below flood flow for at least the first few months after the fire.

The greatest risk is to the community water supply. Floods, debris floods, or debris flows could result in sedimentation that would damage the water intake or the water treatment plant infrastructure. Even without large, damaging floods, the increased transport of fine sediment and changes to chemical composition of runoff from the burned area is likely to degrade water quality in North Nekliptum Creek.

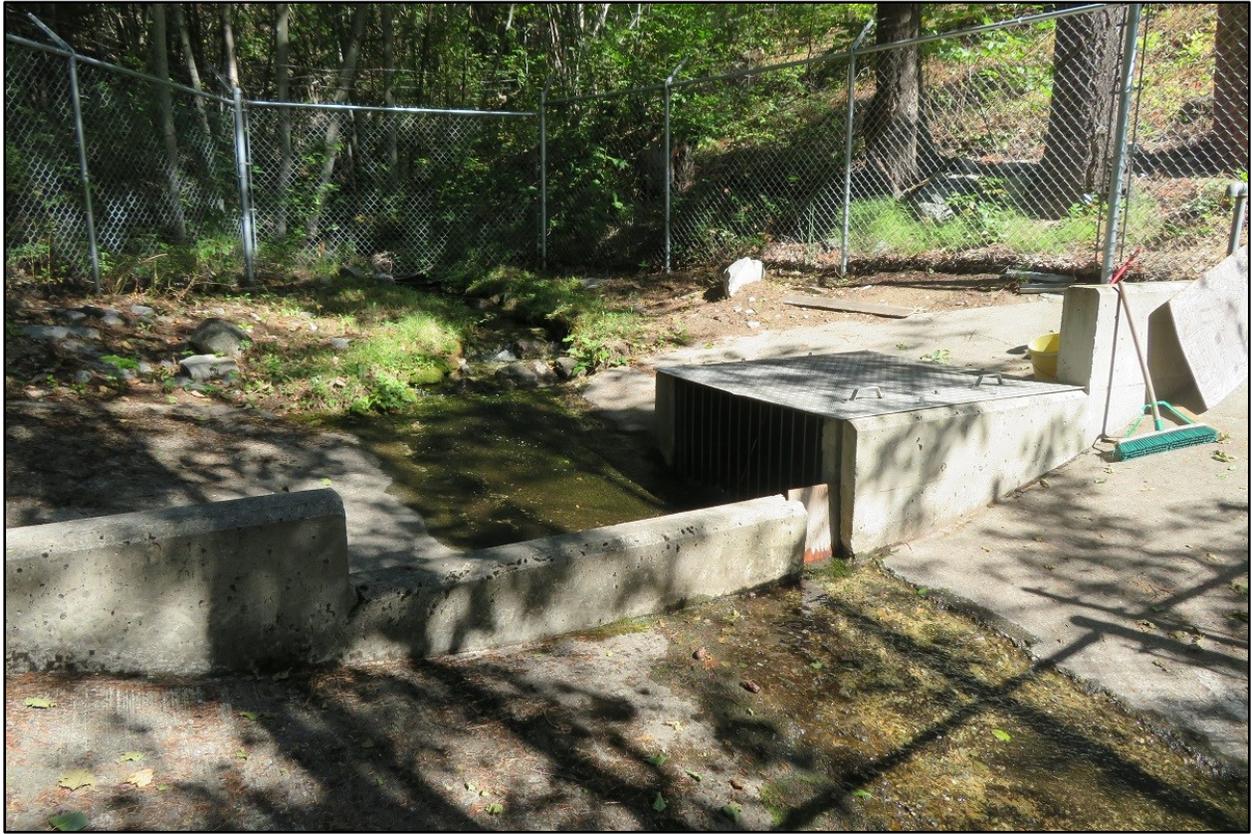
Photo 4: Concrete flume at water intake North Nekliptum.

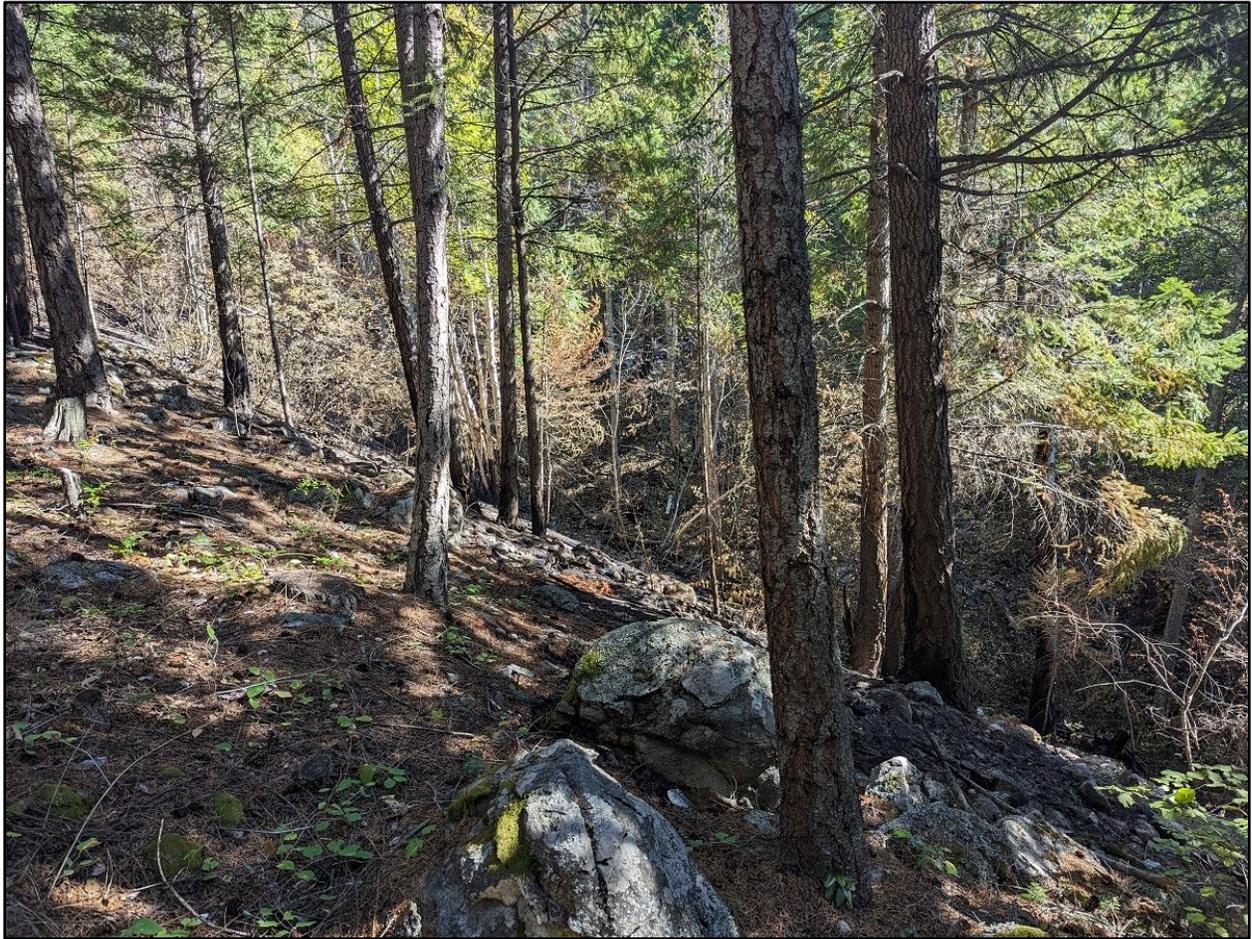
Photo 5: Brush and sediment in North Nekliptum Creek upstream of intake.

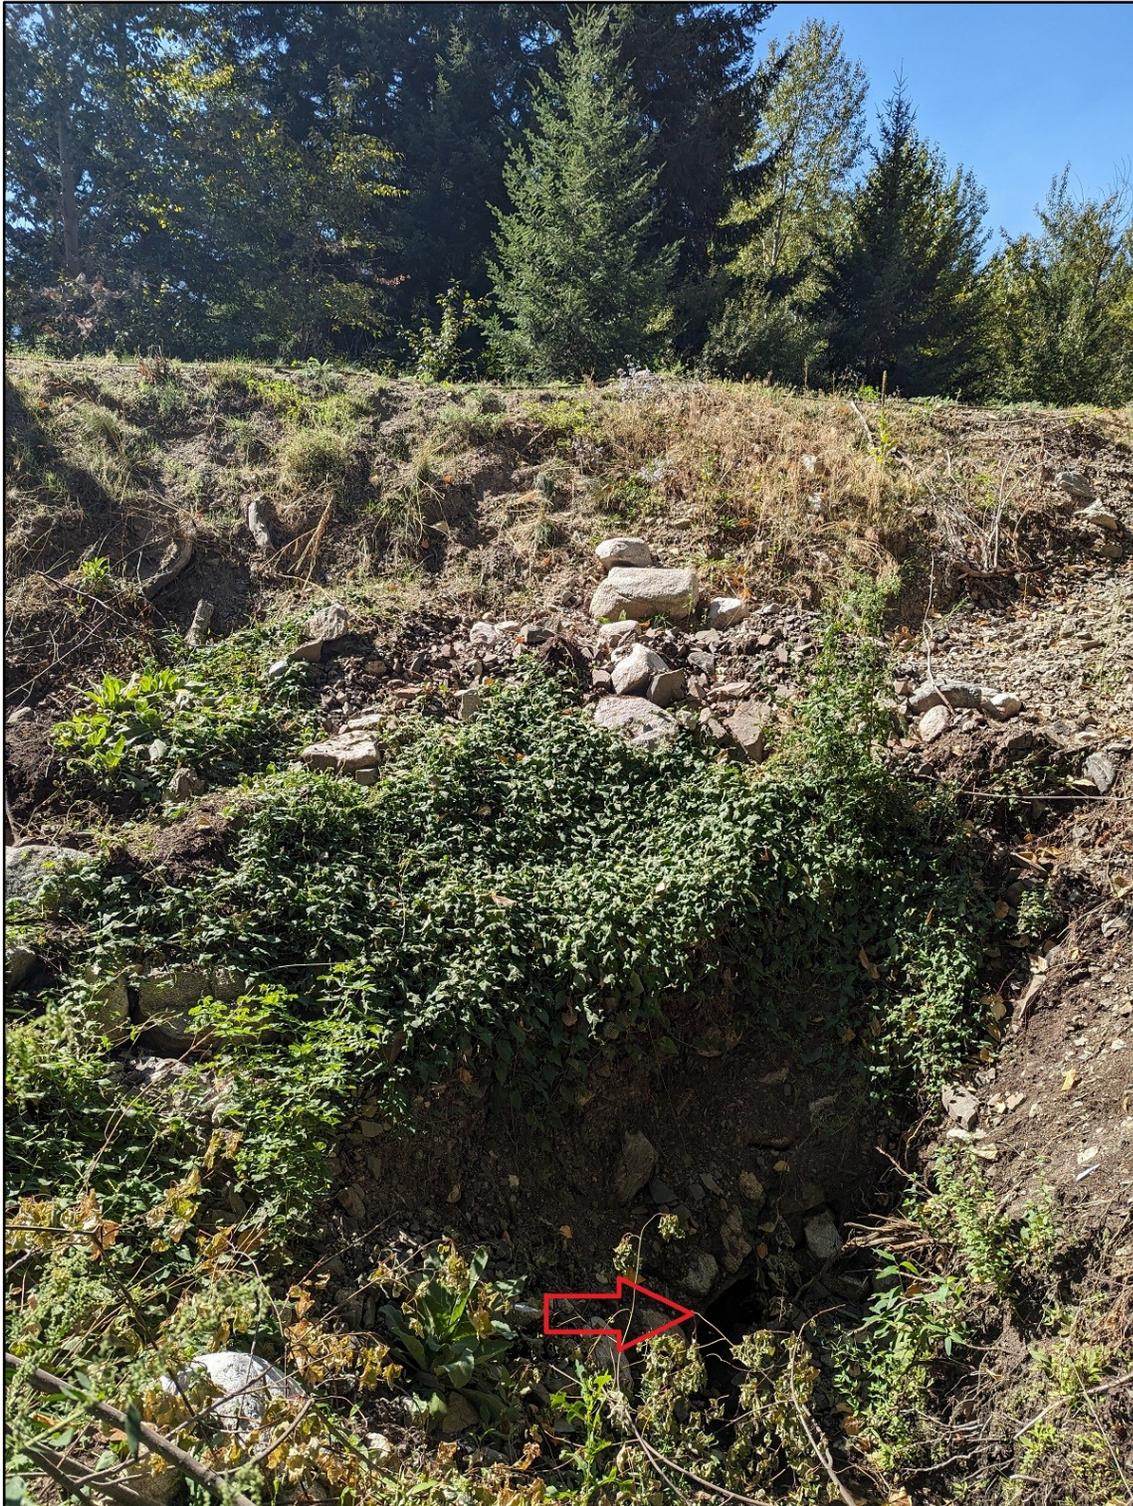
Along Siwash Road, North Nekliptum Creek, Nekliptum Creek, a tributary of Niger Creek, and Niger Creek all flow in draws that are incised a few meters below the level of the road. Metal pipe culverts (500 mm and 600 mm diameter) are in place in each creek channel. The intake to the Niger Creek tributary was damaged, possibly by machine cleaning, and partly blocked with brush and slash (Photo 6) while all of the other culverts were undamaged and free flowing.

Photo 6: Niger Creek tributary at Siwash Road culvert partly blocked by debris.

Upgrading the existing culverts could be considered in conjunction with the installation of upslope debris detention structures or on their own. Given the design flow estimates in Tables 4 and 5, though, upgrading the culverts on their own may not be an effective solution because the potential debris flow and debris flood magnitudes are larger than what even very large replacement culverts might be able to pass. However, it is possible that the upslope debris detention measures, combined with larger culverts, might work together, with the debris detention structures reducing the volume of debris and water reaching the road to a volume that an upgraded culvert can pass without becoming blocked. As with the debris detention measures discussed for North Nekliptum Creek, upslope structures along Siwash Road will require maintenance access to periodically clear debris and sediment to ensure their continued function. Upgrading existing culverts under Siwash Road would also require temporary road closures while new culverts were being installed.

Instead of simply replacing existing culverts under Siwash Road with larger culverts, it might also be possible to replace the existing culverts with paved swales. In a swale design, the road dips to cross each stream, preserving a topographic low point. A small culvert can be installed to prevent normal streamflow from running across the road, but the design is intended so that in floods, debris flows, or debris floods, water and sediment flow across the road, contained within the swale dimensions rather than depositing against it or overflowing down it. Swales still require ongoing maintenance after such events, and their design may limit the size of the largest vehicles that can cross them, such as school busses or lowbed trucks. The time and cost of installing swales should be comparable to the time required and cost of replacing existing culverts with larger ones.

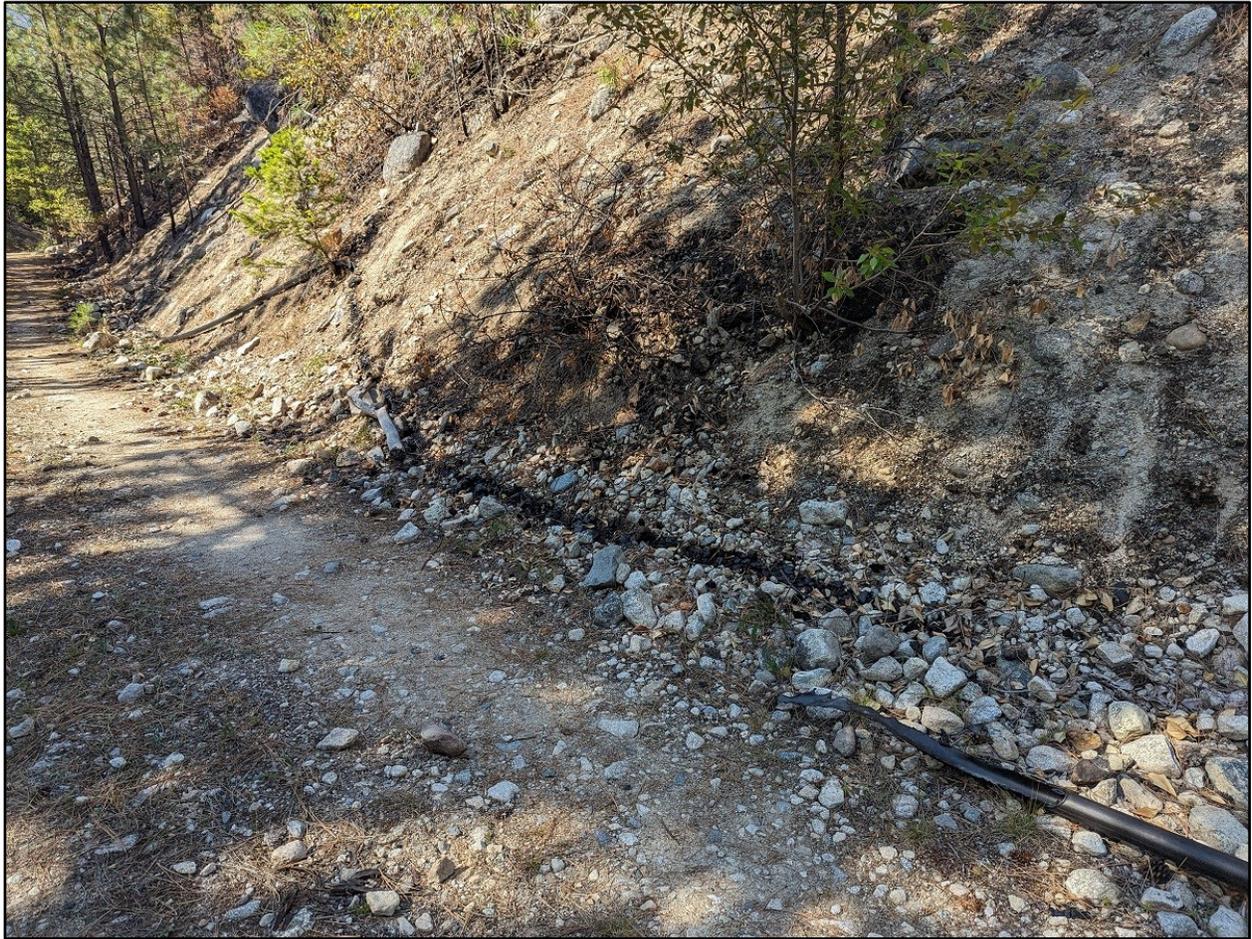
Photo 7: Burned and melted water line on Siwash Creek road.

Debris flows, debris floods, or floods in Siwash Creek will not affect Siwash Road but could damage water supply infrastructure if the existing water license infrastructure is rebuilt after the fire.
